**REHABILITATION OF DETERIORATED REINFORCED CONCRETE
MEMBERS USING ADVANCED COMPOSITE MATERIALS**

**A CASE STUDY OF A DETERIORATED 8-STOREY BUILDING IN THE
CITY OF ABU DHABI IN THE UNITED ARAB EMIRATES**

**A dissertation submitted in fulfilment
of the requirements for the degree of
MSc STRUCTURAL ENGINEERING**

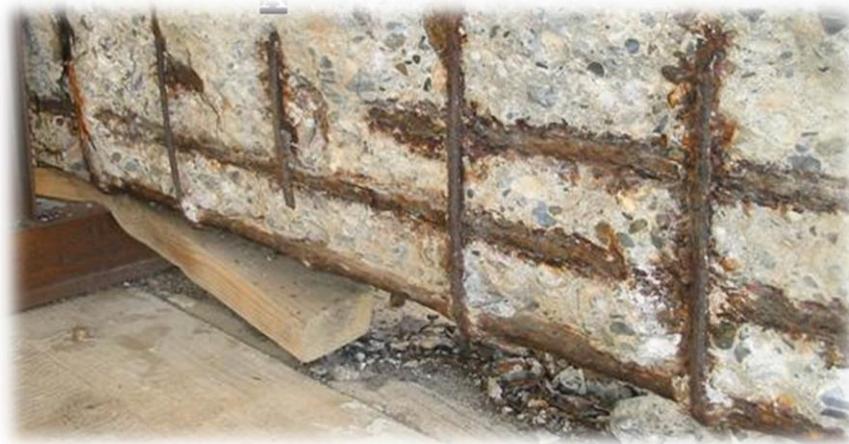
As stated earlier, the deterioration of reinforced concrete and the substantial damages to the civil infrastructure resulting from rusting of steel (Figure 2.1 below), as well as the aging of the structures had imposed a great deal of research on the material to be utilized in the rehabilitation and retrofitting of the concrete structures. Furthermore, the reformation, renovations, and function alterations applied on the structure after construction, as well as various sustainability factors affecting the built structure and inaccuracies/errors made during the design and/or construction stages have contributed to the advancement of composite materials.

Figure 2.1 - Corrosion of Steel Rebar in Concrete

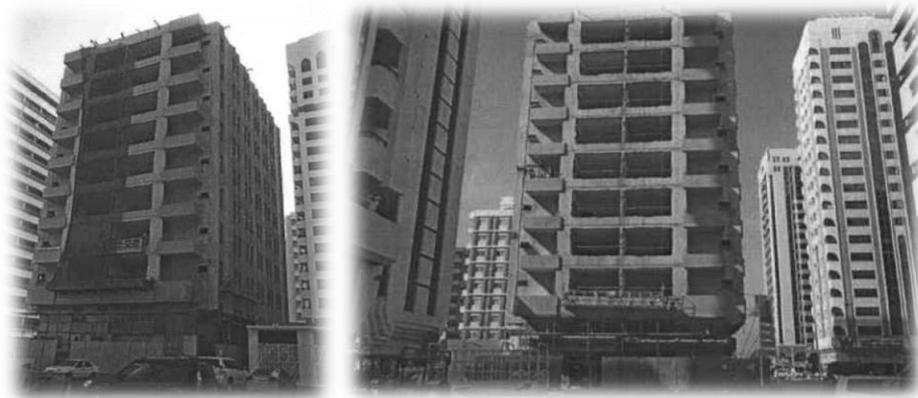
over piles. The building under consideration can be seen in Figure 5.1 below:

Figure 5.1 – Structure Undergoing Investigation.

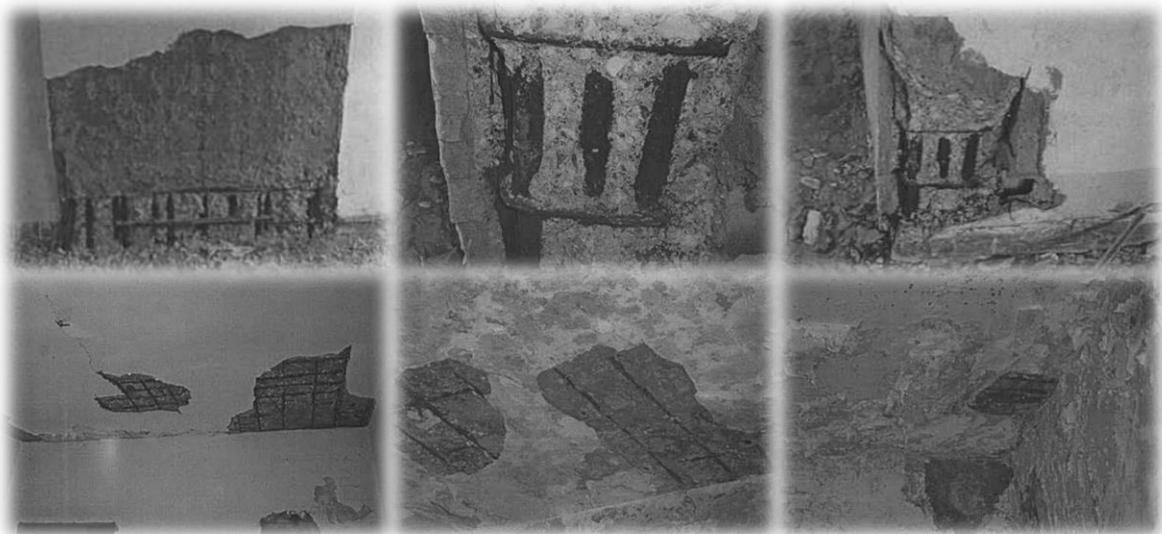
The visual inspection of the building revealed an immense extent of cracking and delamination in the concrete due to steel corrosion. The corrosion of various steel reinforcements in diverse structural elements is visible. Accordingly, the corrosion can be seen in structural columns, as well as slabs revealing signs of a previous severe leakage. As a result, delamination and breakage of concrete surface is observed as illustrated in Figure 5.2 below:

Figure 5.2 – Corrosion of Steel Reinforcement in Structural Members (Columns and Slabs)

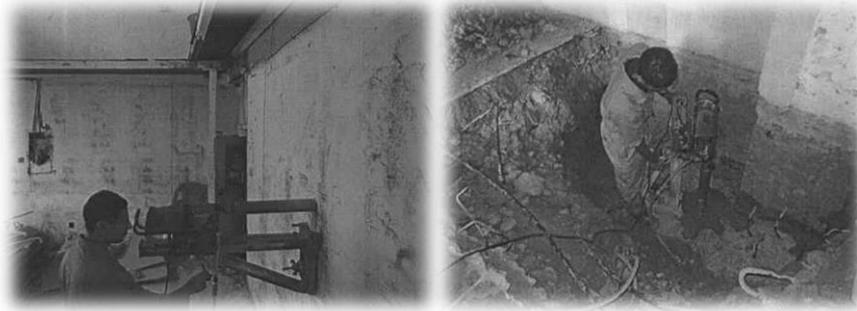
The coring is done through sampling of five different columns in various locations and one pile cap was performed utilizing the coring of the columns (horizontally) and the pile-cap (vertically) in the building are shown in Figure 5.3 below:

Figure 5.3 – Coring Samples from Columns and Pile Cap

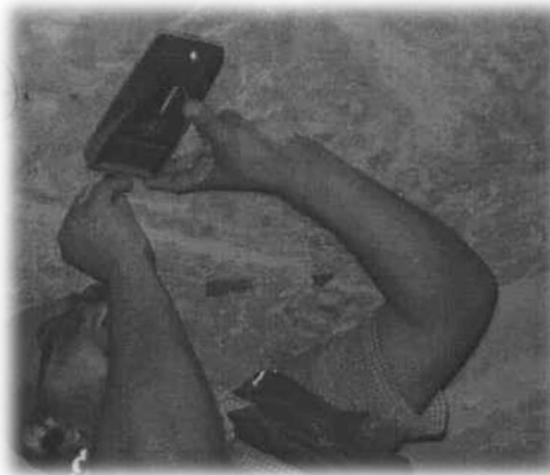
Figure 5.4 - eFORCE Team Measuring the CC and Identifying the Steel Bars Locations

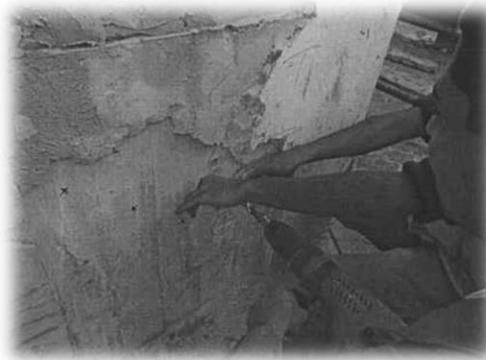
Figure 5.6 - Dust Sampling

In the 8-storey building under consideration, the dust samples were gathered from columns as well as the pile cap as seen in Figure 5.6 above and are tested utilizing the Sherwood Model 926 device. Furthermore, the results data are presented in Table 5-4 below:

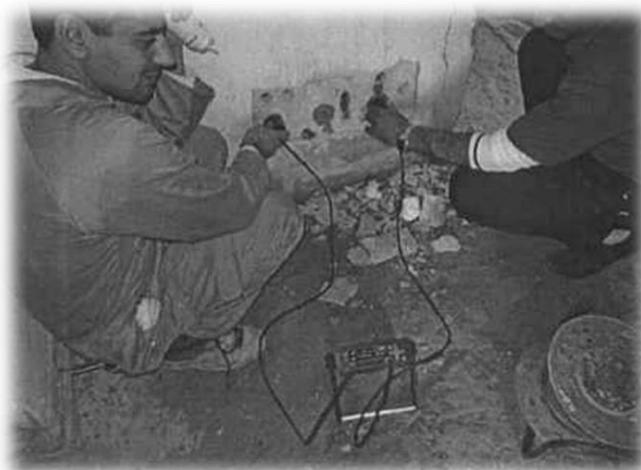
In order to determine the quality and soundness of concrete, the Ultrasonic Pulse Velocity Test was used as illustrated in Figure 5.7 below:

Figure 5.7 - During measuring the Ultrasonic Pulse Velocity

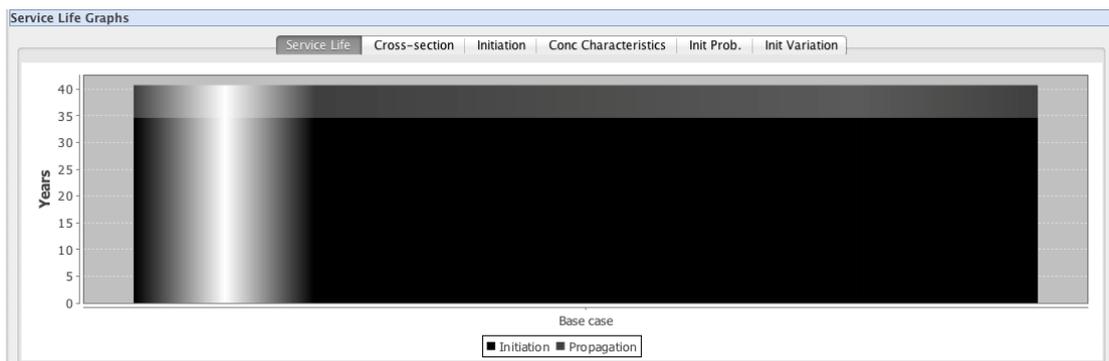
The service life model showing the initiation and propagation periods (IP and PP respectively) of the analyzed structure is illustrated in Figure 5.16 below:

Figure 5.16 – Service Life of the Struc. Illustrating the IP and PP

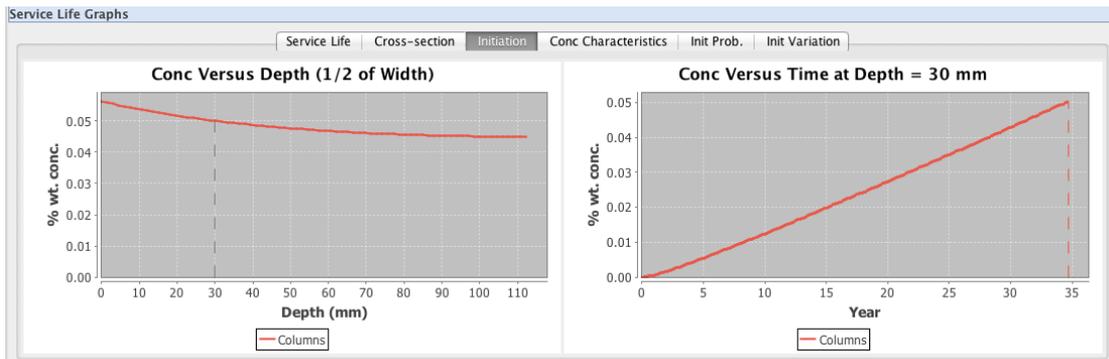
The concentration of chlorides (on the vertical axis) at each depth of the analysed columns at the time of initiation as well as the level of chlorides variations at the reinforcing steel (on the vertical axis) at each point in time up to the time of initiation respectively are illustrated in Figure 5.18 below:

Figure 5.18 – Conc. of Chlorides at Each Depth of the Structure & the Level of Chlorides at the Reinforcing Steel with Time Respectively

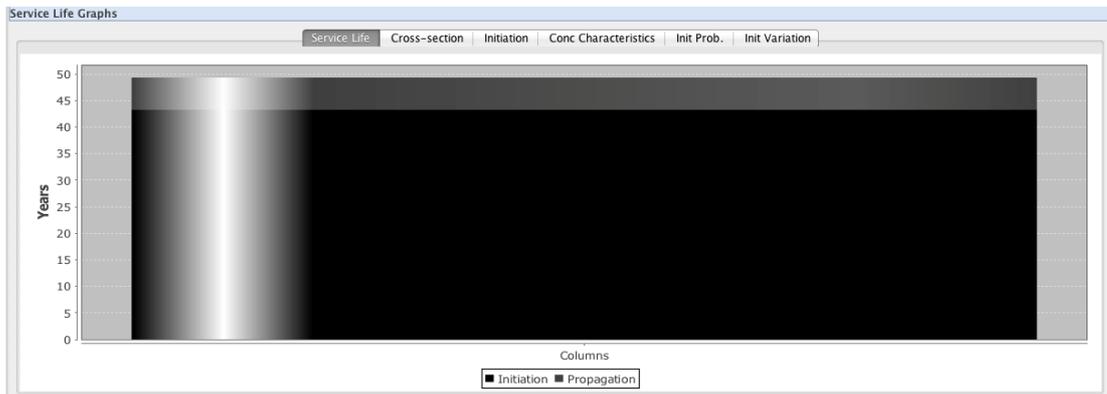
Figure 5.24 – Service Life of the Repaired Structure Illustrating the IP & PP
