**Assessment of Structural Elements Deteriorated in Semi-
Arid Environmental Conditions**

**Dissertation submitted in partial fulfilment
of the requirements for the degree of
Msc STRUCTURAL ENGINEERING
at
The British University in Dubai**

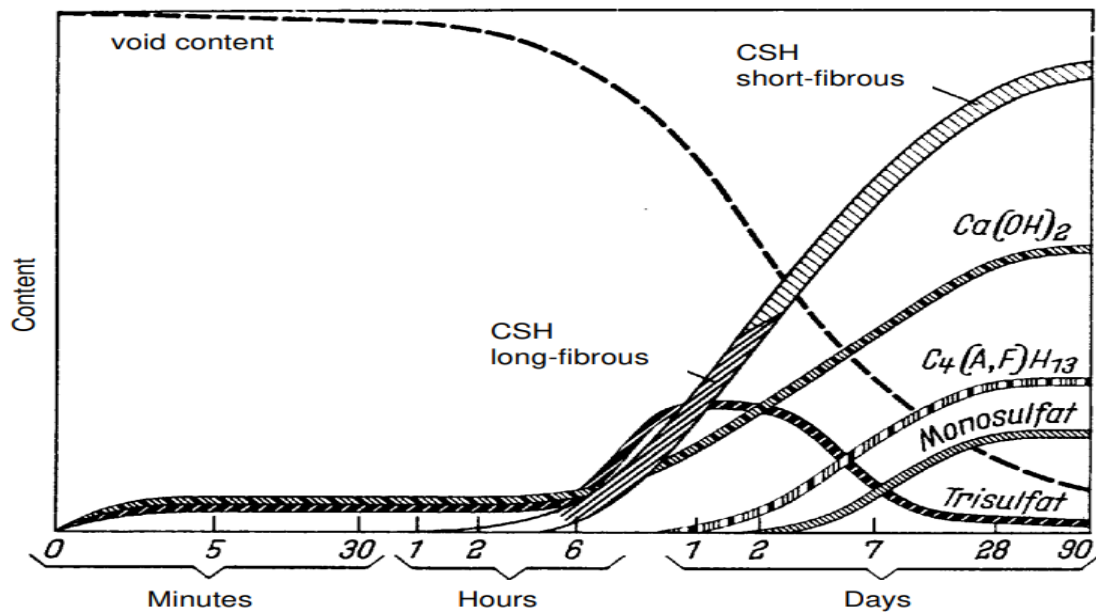
Figure 3 Formation of hydrate phases and the structure development during cement hydration (Locher 1976)

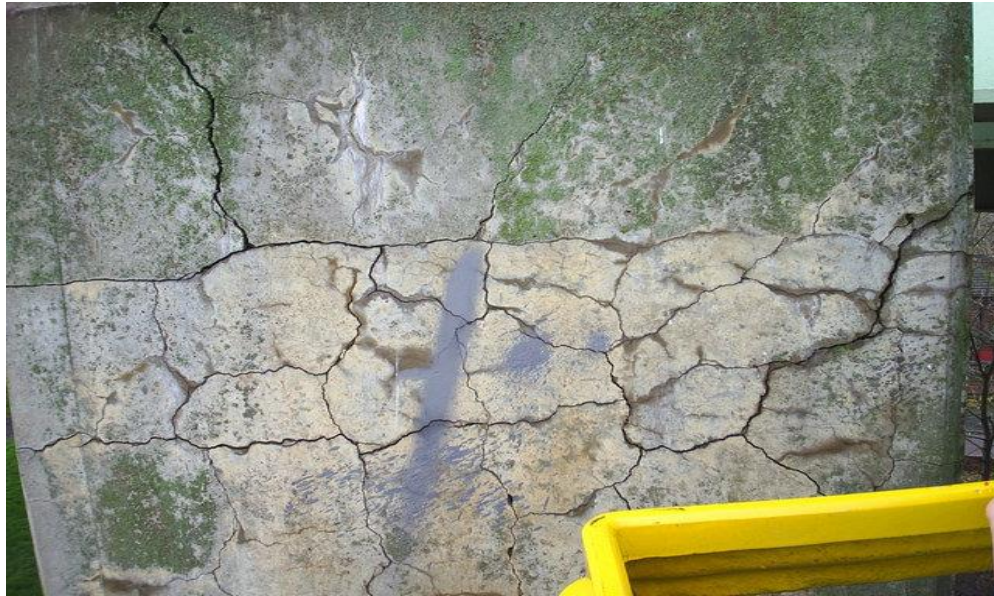
The crucial factors that affect alkali aggregate reaction are alkalis, moisture, temperature, and the pozzolanic conditions. Feldspars, micas and clay minerals contained in the limestone and clayey material which are often used as raw material in manufacture of cement are the source of the alkaline nature that forms the basic property the concrete. The progress of AAR is dependent on the availability of moisture. This chemical reaction is greatly reduced in the absence of water. This reaction, therefore, is more on the surface of concrete where water is easily available. By the application of water proofing agents on concrete which prevents additional penetration of water into the structure can enormously reduce the alkali silicate reaction. Expansion due to reaction between bases and aggregates may be prevented or reduced by replacing 20-30 percent cement by a suitable pozzolan as it is scientifically proved that the pozzolans have a huge influence on some of the reactive aggregate and can also prevent the expansion caused by the alkali silica reaction in the aggregates (Gillott 1975).

Figure 7 Cracking due to alkali aggregate reaction in Concrete (Brueckner & Lambert 2013)

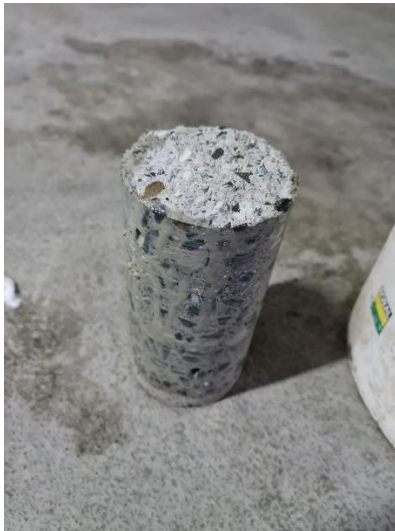
Fig. 18 (A) Cylindrical Core Specimen

In the United Arab Emirates, the building is inspected on a regular basis to ensure the safety of the residence in the country. The data is obtained by performing various non-destructive test on the deteriorated buildings. The data for compressive strength test is collected by performing compressive strength test on concrete core obtained by drilling in the deteriorated structures. The figure 18 (A) illustrates an image of obtained cylindrical core via drilling and the figure 18 (B) exhibits the core tested under compressive testing machine

Figure 18 Cylindrical Core & Its Testing Under Compression

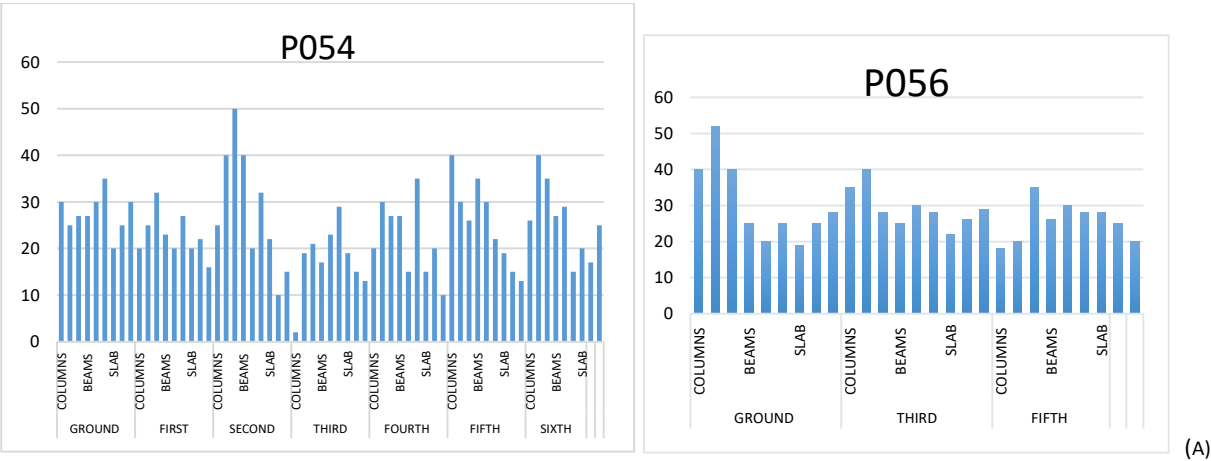
Figure 22 shows the varies carbonation values throughout the projects assessed. It can be observed from the graphs that the carbonation values tend to rise to a certain elevation then they fall. The peak carbonation values occur at first and second floors for almost all the projects. This peak carbonation at a particular level can be due to higher carbon dioxide concentrations at those levels or It can also be attributed to higher relative humidity at those levels.

Carbonation Values by level in P054 (B) Carbonation Values by level in P056

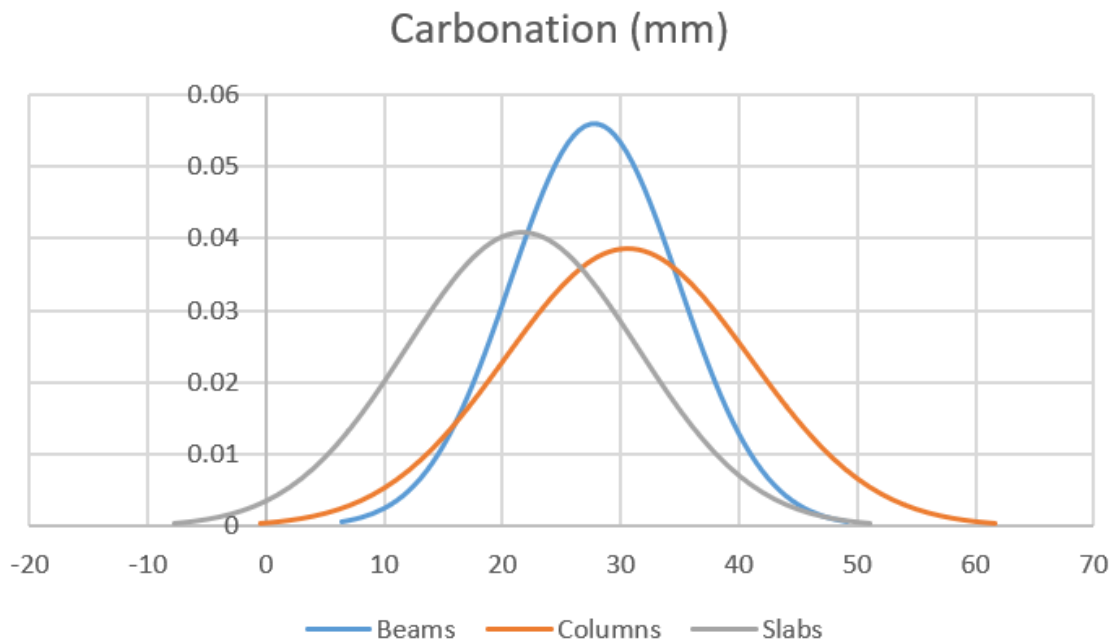
carbonation with the peak of normal distribution with the highest frequency at 21.6mm. Furthermore, the beams are the second most carbonated elements the peak of normal distribution with the highest frequency at 27.8mm. and finally the columns exhibit the highest normal distribution for the maximum frequency at 32mm. From this we can understand that the columns have more tendency to be exposed to carbonation than beams and slabs.

Figure 23 Normal Distribution Curve for Carbonation of different structural elements

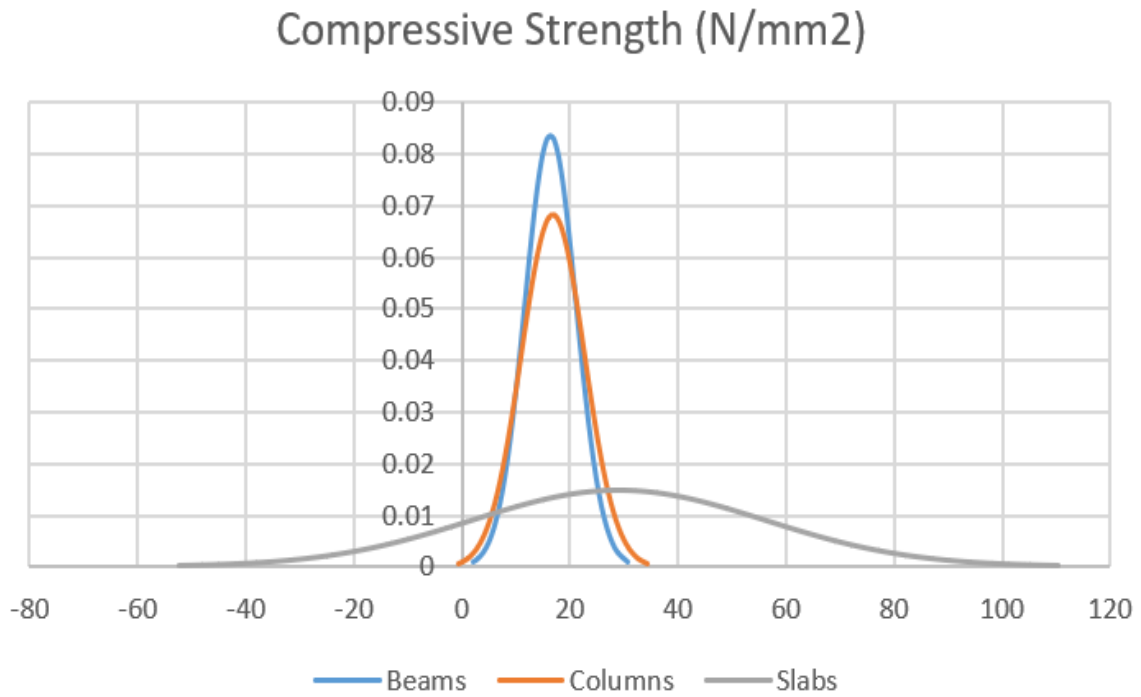
like that ultrasonic pulse velocity. Thus we can tell that columns and beams are more exposed to deterioration than slabs, and exhibit a similar behaviour in deteriorating.

Figure 25 Normal Distribution Curve for Compressive strength of different structural elements

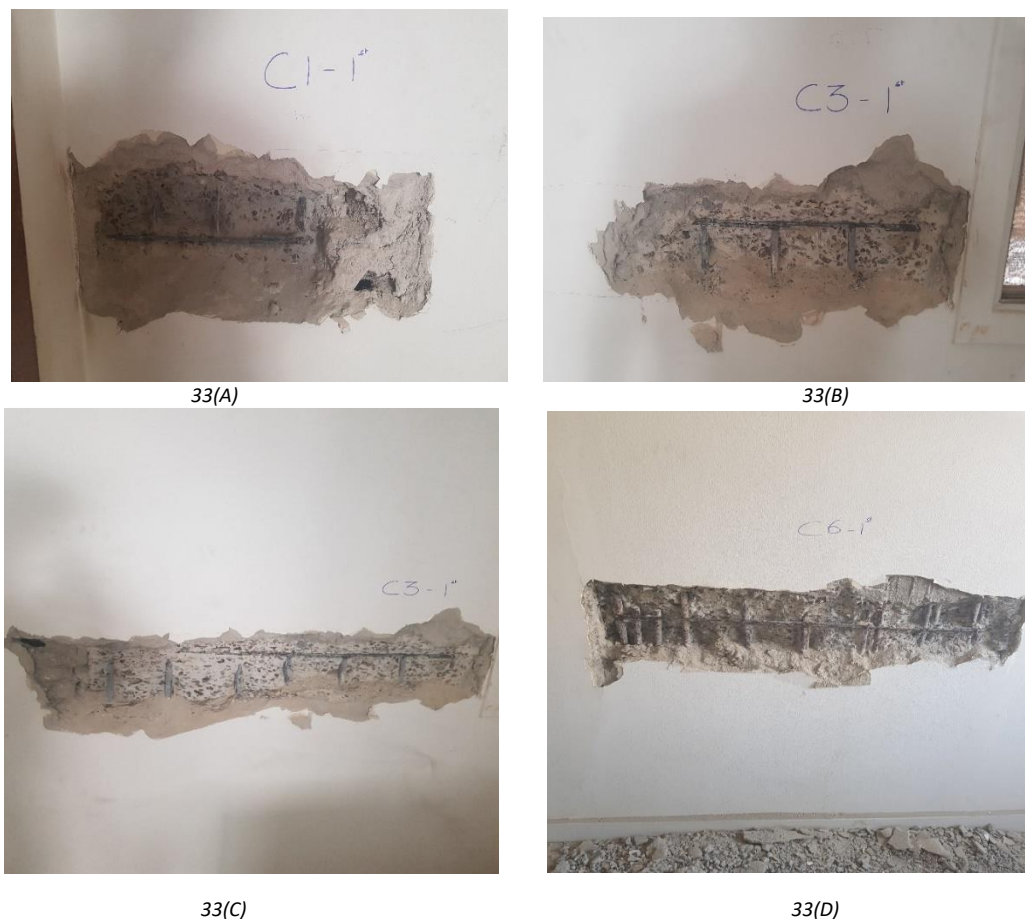
After acquiring the initial size of the structural elements the reinforcement data was acquired for the columns, the reinforcement data was available for the beams and the slabs. To acquire the data of reinforcement for the columns the cover of the column was removed to visible see the reinforcement provided and then was immediately covered up using micro concrete to avoid further deterioration. another way to procure this data was by ultra-sonic scanning. This method of removing the concrete cover was chosen as it was comparatively cheaper. The columns were classified into groups and few elements of this group were chosen to acquire the data. The following images exhibit on the reinforcement data acquisition of the columns. The Figure 33 exhibits image of retrieving columns data by chipping of cover for Ground floor.

Figure 33 Reinforcement for columns in ground & first floor. (A.) column C1, (B.) column C3, (C.) column C3 middle, (D). Columns C6

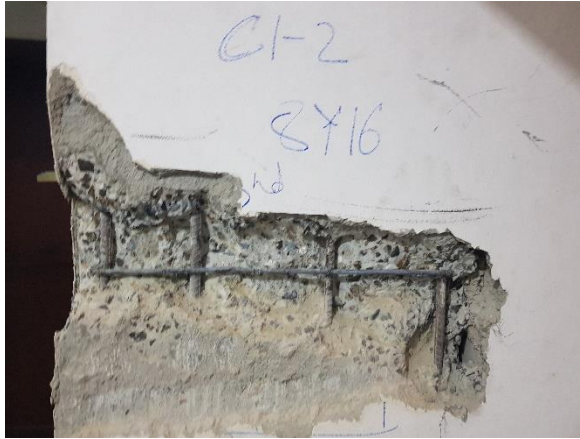
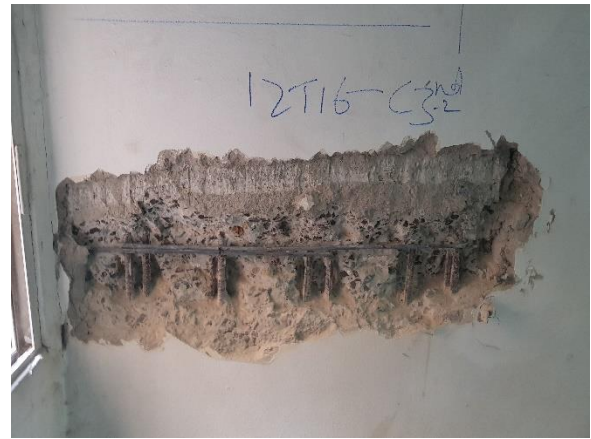
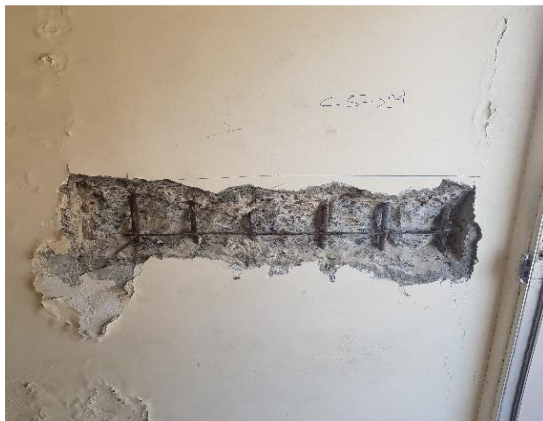
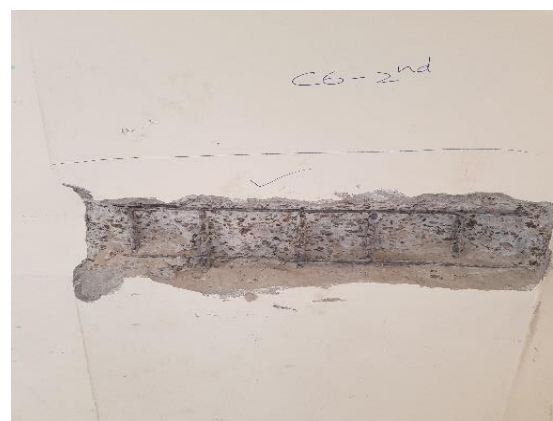
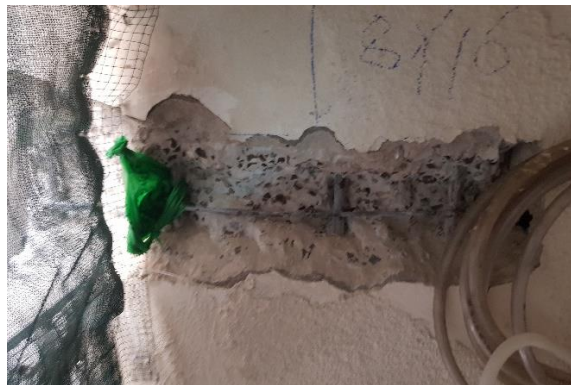
Figure 34 Reinforcement for columns in second floor. (A.) column C1, (B.) column C3, (C.) column c5, (D.) Columns C6 and (E.) column C4

The images shown below (figure 34) exhibit the chipping of the cover of the reinforced cement concrete column in the second floor in order to visually see the reinforcement provided in the columns

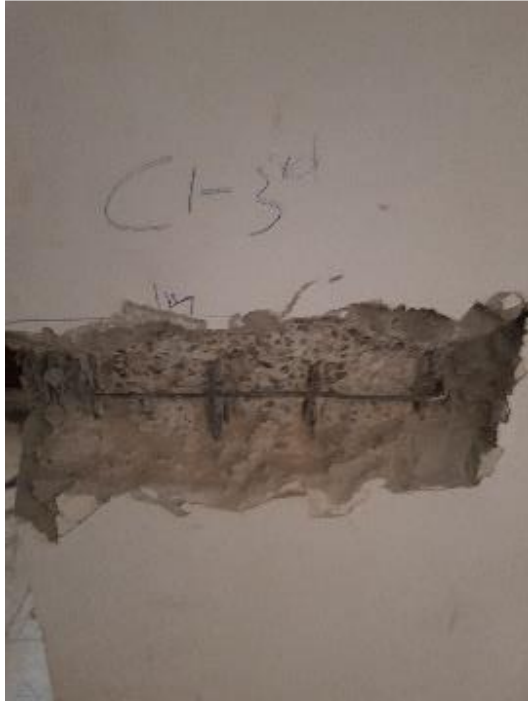
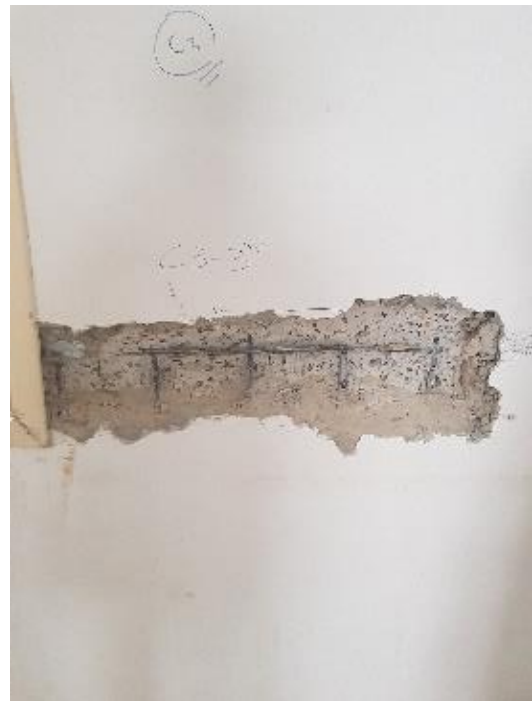
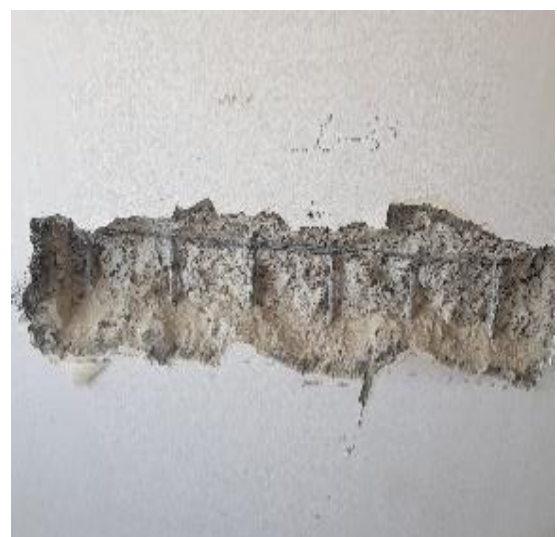
Figure 35 Reinforcement for columns in third floor. (A.) column C1, (B.) column C3, (C.) column C4, (D.) Columns C6

The images shown below (figure 35) exhibit the chipping of the cover of the reinforced cement concrete column in the third floor in order to visually see the reinforcement provided in the columns

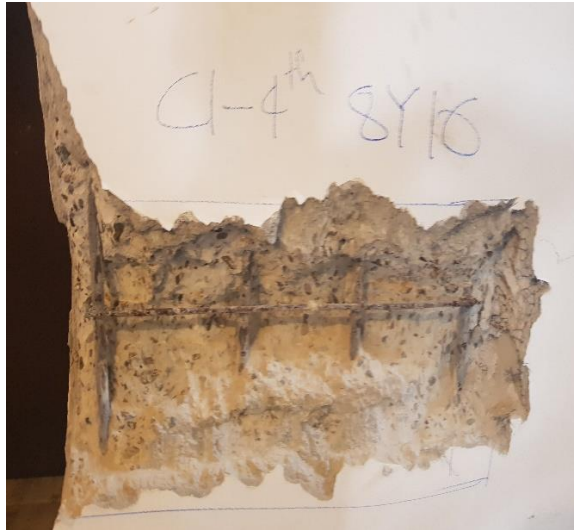
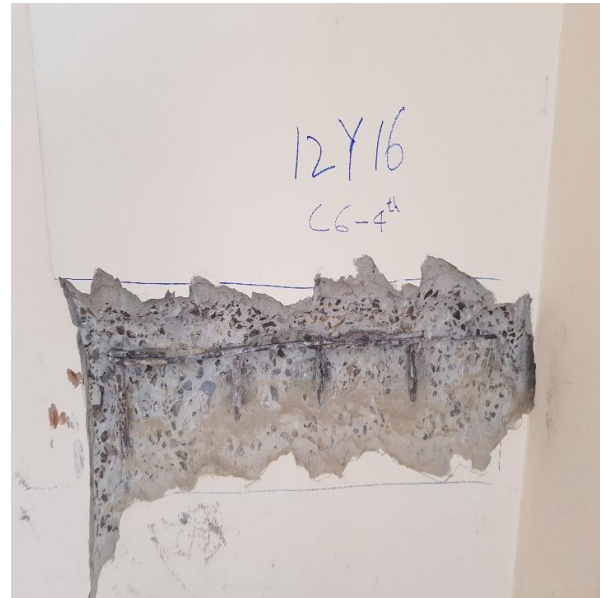
Figure 36 Reinforcement for columns in fourth floor. (A.) column C1, (B.) column C3, (C.) column C5, (D.) Columns C6

The images shown below (figure 36) exhibit the chipping of the cover of the reinforced cement concrete column in the fourth floor in order to visually see the reinforcement provided in the columns

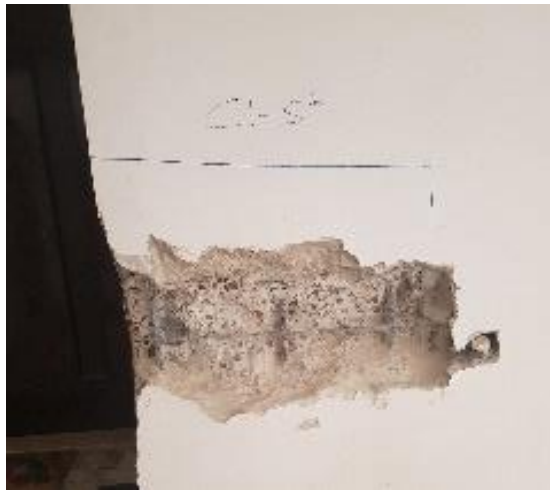
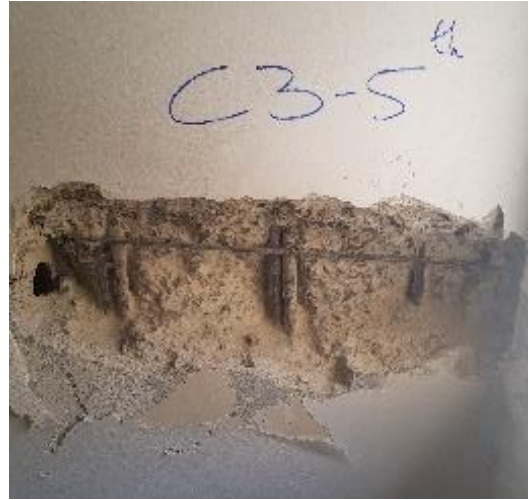
Figure 37 Reinforcement for columns in fifth floor. (A.) column C1, (B.) column C3

The images shown below (figure 37) exhibit the chipping of the cover of the reinforced cement concrete column in the fifth floor in order to visually see the reinforcement provided in the columns

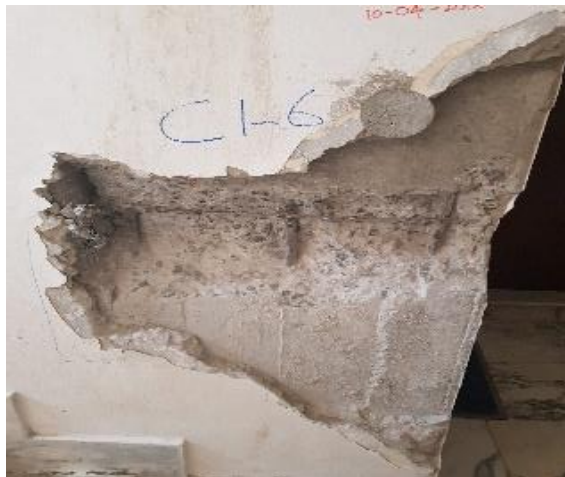
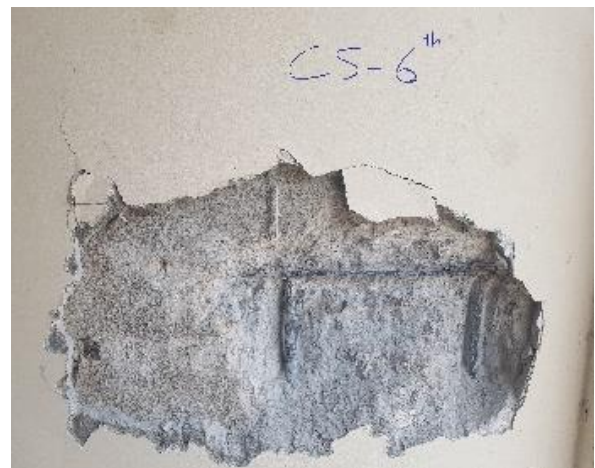
Figure 38 Reinforcement for columns in sixth floor. (A.) column C1, (B.) column C5

The images shown below (figure 38) exhibit the chipping of the cover of the reinforced cement concrete column in the fifth floor in order to visually see the reinforcement provided in the columns
