Seismic strengthening of Reinforced Concrete Structures using External Lateral Post Tensioning

USHA MURUGESAN

**Dissertation submitted in fulfilment
of the requirements for the degree of
MSc STRUCTURAL ENGINEERING
at**

The British University in Dubai

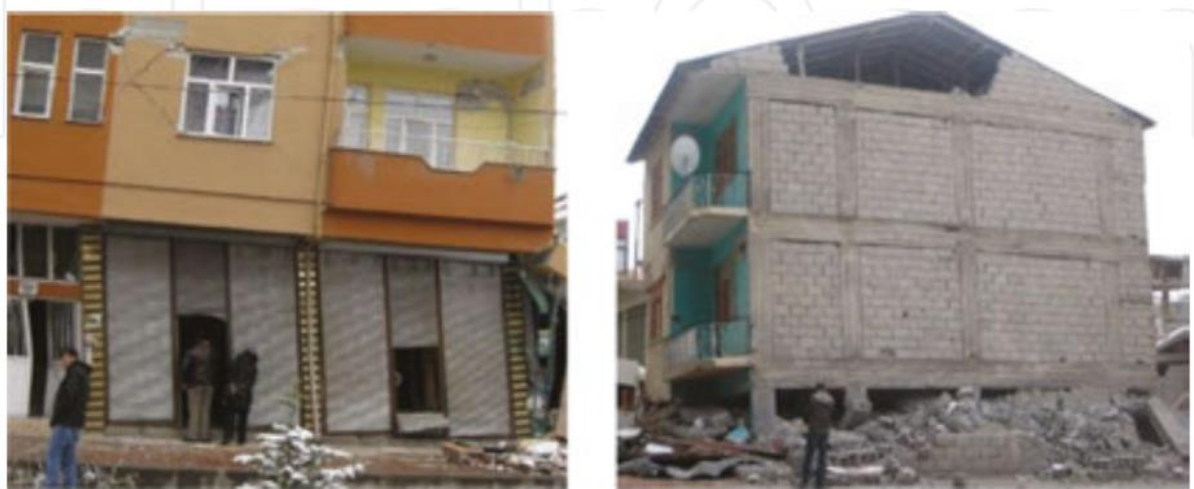
FIGURE 2.7: Soft storey causing unexpected inter storey drift (Earthquake & Structural Damages)

of the structure. Apart from this most of the time the below of the ground level are enclosed with windows made of glass instead of using brick infill walls. The above part of the ground level is constructed with partition walls for rooms for residential purposes. These are some of the reasons which can affect the end of a column by brittle failure. It is found that the soft-story mechanism is one of the most common modes of failure in a mid-rise RCC structure mostly in the first story. In any building, a weak story is made when failures tend to concentrate on a particular story if there is a sudden change in lateral strength in b/w of the stories adjacent. These sudden changes are due to the absence or lack of partition walls or this is due to the reason of insufficient column's cross-section. Hence these issue leads to the potential collapse partially or totally of a building during an earthquake. The following images are the representation of the damages.

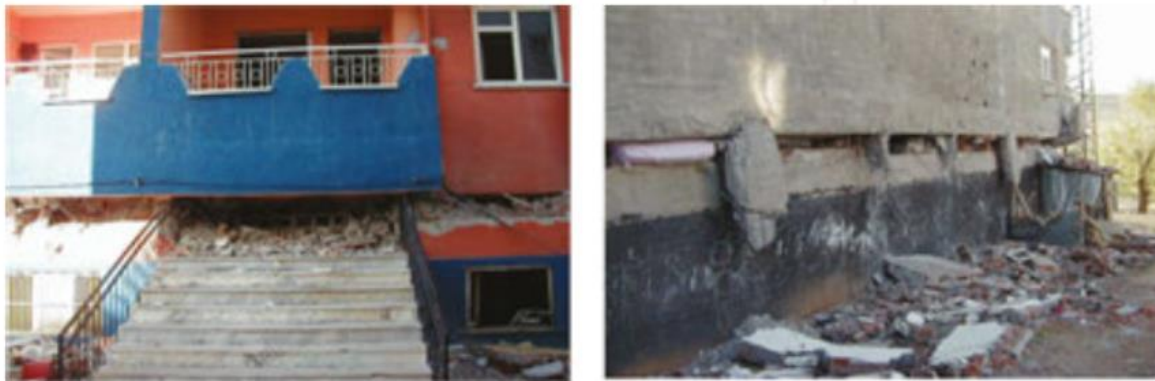
**FIGURE 2.8: A representation due to weak story mechanism
(Earthquake & Structural Damages)**

At the time of a seismic event, there is an increase in shear forces at the beam-column joint as well as at the columns. Hence great attention and care has to spare to the design as well as a constructional aspect of the columns and the beam-column joint for the approach of performance-based design, the structures will have an increased ductility for the concern of seismic design. Most of the time there is a lack of transverse reinforcement in the area of the plastic hinge at columns of a structure. Due to which these structural elements will have low performances when experienced by dynamic loads. They lose their axial and shear load-carrying capacity. The following figure is the representation of this mode of failure.

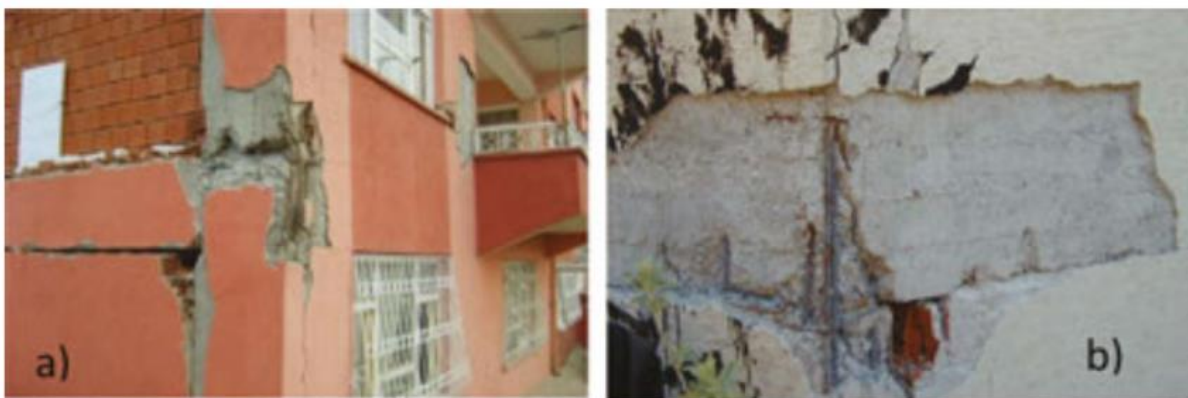
**FIGURE 2.9: Inadequate spacing between shear reinforcement causing structural failure
(Earthquake & Structural Damages)**

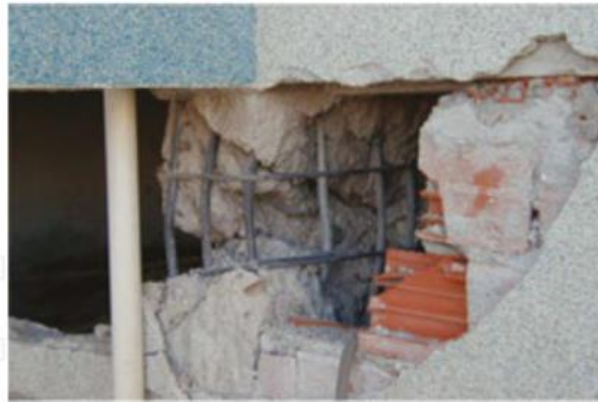
FIGURE 2.10: Representation of damages on short column (Earthquake & Structural Damages)

Due to the adjustments done to the structural, maybe top continuous openings of infill walls which are in between the columns which helps the mechanisms of such type develops. The columns and the shear walls will be the main element to take the lateral forces produced from an earthquake. These loads dissipation depends on the column's length which is a major aspect as well. The stiffness and the vulnerability to being brittle depend on the length of the column if the length decrease then it will be stiffer as well as more brittle in nature than the surrounding columns. Moreover, this insufficient length column tends to attract more shear forces. Due to which the shear failure occurs to such columns that are of concrete and hence the damages. The following figure is of a short column.

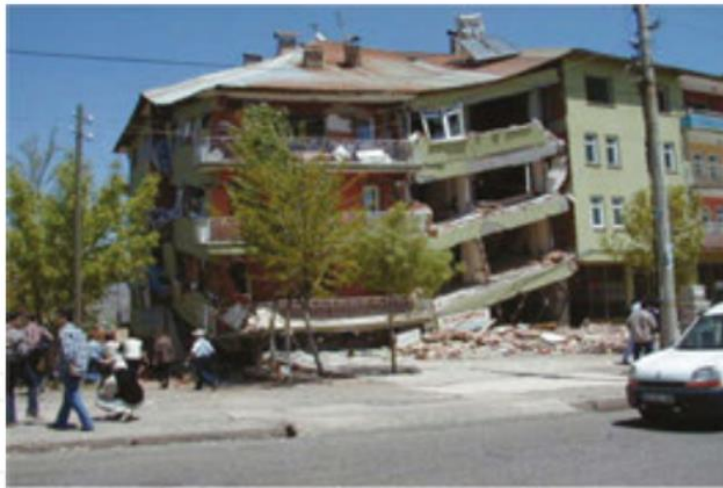
FIGURE 2.11: Adjacent building collapse (Earthquake & Structural Damages)

Since there would be a lack of lots for the building in certain areas these structures tend to be constructed near to each other. One or two building's faces may be in contact. Therefore, during a seismic event, the lack of gap will start to pound each other. The pounding effect becomes very dangerous when the floors of the structure are not maintained at the same level. The following image shows the damage caused due to this lack of a gap between the buildings.

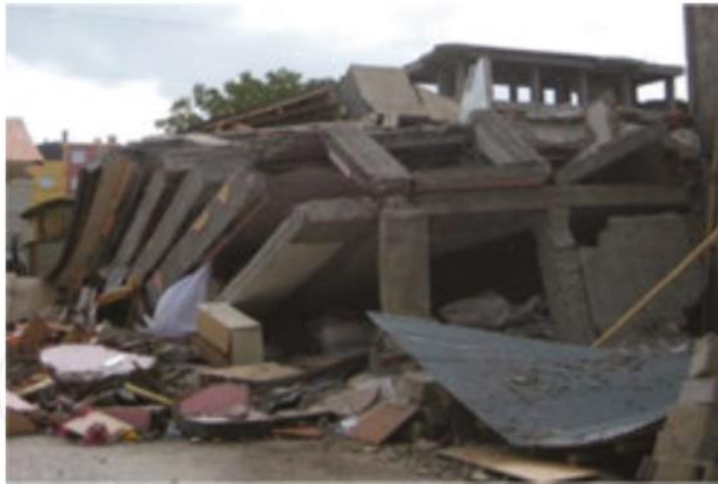
FIGURE 2.12: Strong beam weak column effect causing structural failure (Earthquake & Structural Damages)

Sometimes for a flexibly designed column rigid and deep beams are used. Due to which the resistance towards the moment becomes more for the beam because of the dynamic loads than columns that are weak. Due to such approach shear failure, elastic behaviour or compression crushing leads to the plastic hinges over a column designed to flexible during a seismic event. The mode of strong beam weak column failure mechanism can be illustrated in the following image

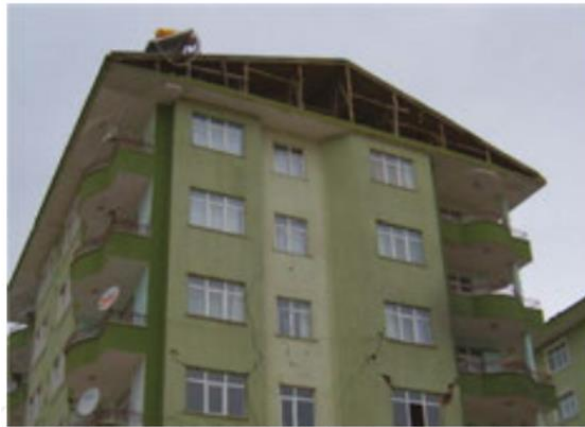
FIGURE 2.13: Gable walls failure on the top of building (Earthquake & Structural Damages)

Out of plane collapse is the most common mode of failure at the gable walls during an earthquake. Even though the gable walls are considered non-structural damages it may lead to loss of properties and lives. The damages over these walls can be due to reasons of lack of stability as well as the large lengths of walls which are not supported. The following is an image representation of such failures.

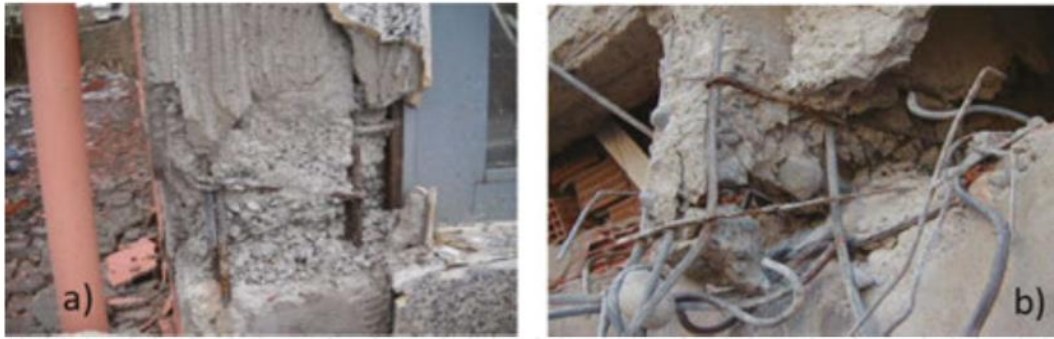
FIGURE 2.14: Poor quality of concrete leading to structural failure (Earthquake & Structural Damages)

Lack of workmanship and the use of low strength concrete is yet another major reason for damages caused in a building. The most important factor to resist against an earthquake is the quality of concrete used for construction. Old buildings were generally constructed without the use of vibrators. So, the homogenous mixing was not available hence the required compressive strength was also lacking in these buildings. Moreover, the use of the corrosion-prone the Reinforcement bars, improper granulometric aggregates as well as utilizing a steel reinforcement which is smooth affects the concretes strength. These types of damages are shown in the following images.

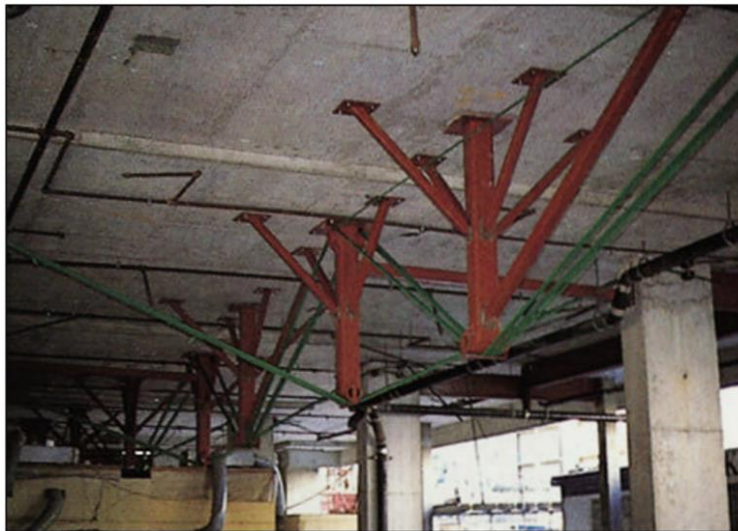
FIGURE 2.23: Representation of saddles and tendons pre fire proofing (Repair & Retrofit using External Post Tensioning)

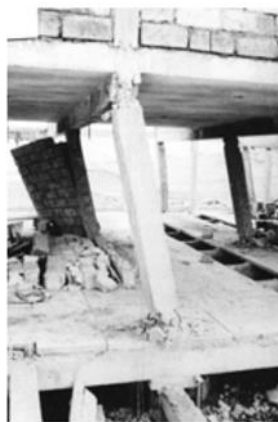
FIGURE 3.5: Structural failure before collapse (Reinforced Concrete Construction Failures Exposed by earthquakes and other)

It is found that the top and the bottom of a ground level columns experience moment forces to be maximum making these areas to be the weakest in construction. Moreover, the quality of the concrete used is too low as well as there were no confinements where integrated to the columns in the areas of maximum moment force.

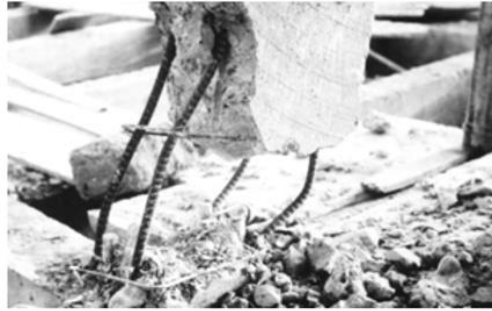
FIGURE 3.6: Structural failure due to lack of confinement (Reinforced Concrete Construction Failures Exposed by earthquakes and other)

The interaction between the concrete and the steel depends on the strength of reinforcement of the concrete where compression resistance from the concrete and the tension resistance from the steel will be worked. If the quality of the concrete used is compromised or forces exceedingly as per the design is experienced then the concrete crumbles and falls away from steel putting a stop to the interaction. Hence this will cause the steel to buckle resulting in the eventual collapse of the building. This is the most common mistakes encountered in the construction of the building in rural as well as the urban structures. Moreover, inadequate stirrups design in the areas of the maximum moment is also another example of a common mistake found.

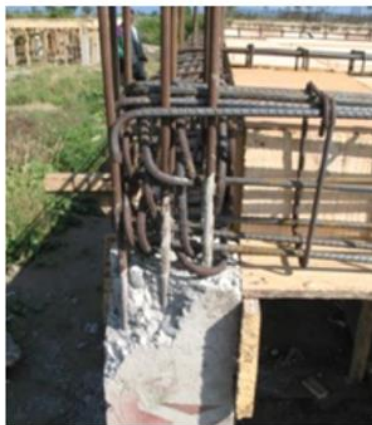
The reinforcement bars bend end can subject to crowding at the corner of a RCC structure when the floor beams are found to be joint at the column which is at the corner. When a problem like this arises, a structural engineer has to identify which of those horizontal bars are to withstand/resist the max. moment forces. If there is an overloading case at the time of a seismic event then the first to fail/bend should be the end of the beam before columns of the building.

FIGURE 3.11: Improper detailing leading to reinforcement overcrowding (Reinforced Concrete Construction Failures Exposed by earthquakes and other)

The 4 issues exhibited in the above picture is as follows: -

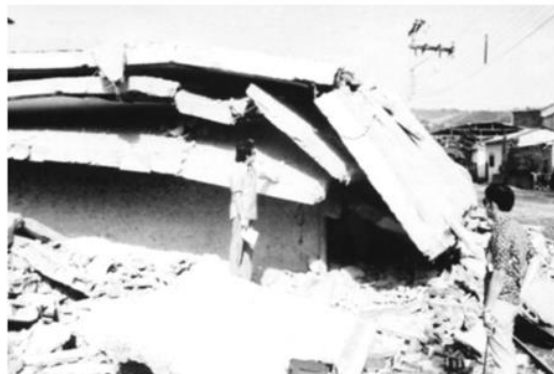
FIGURE 3.15: Modifications by Users without consulting Engineers increasing the slab thickness leading to collapse (Reinforced Concrete Construction Failures Exposed by earthquakes and other)

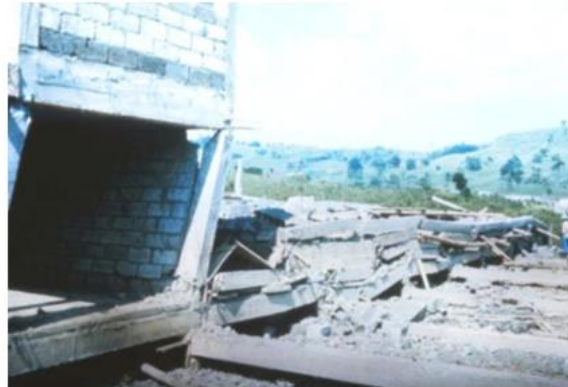
FIGURE 3.16: Modifications by Users without consulting Engineer's absence of shear walls leading to collapse (Reinforced Concrete Construction Failures Exposed by earthquakes and other)

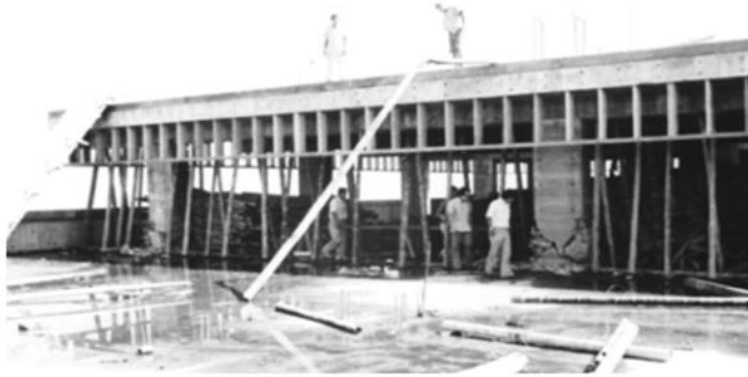
FIGURE 3.17: Improper engineering designs leading to collapse (Reinforced Concrete Construction Failures Exposed by earthquakes and other)

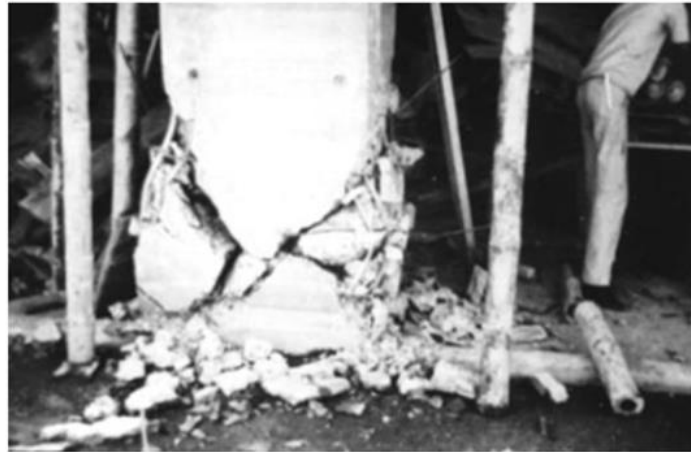
FIGURE 3.19: Improper detailing of column base (Reinforced Concrete Construction Failures Exposed by earthquakes and other)

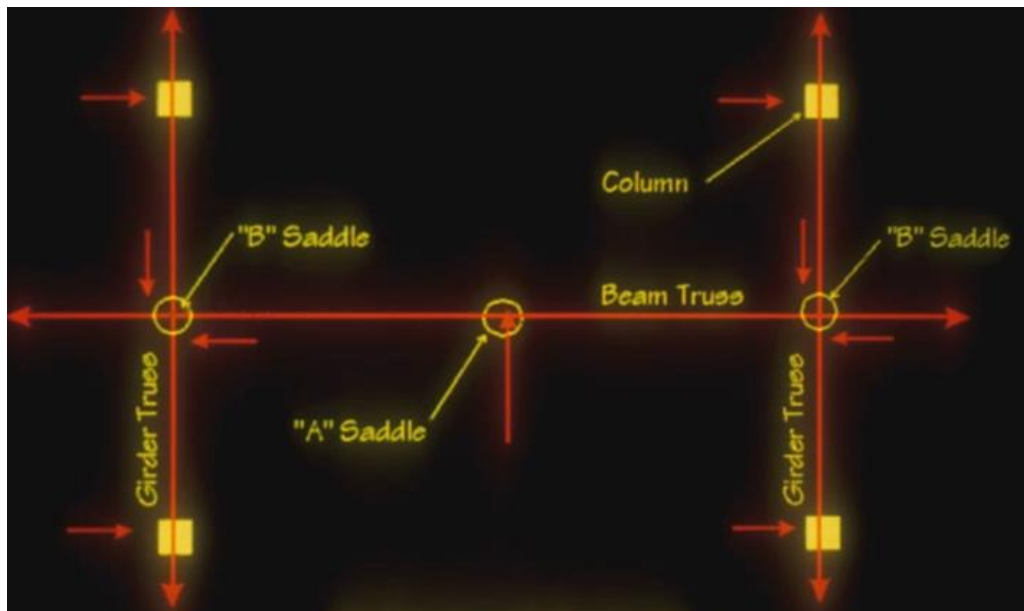
FIGURE 4.6: Schematic of Load application of orthogonal trusses (ACI-318, CEU)

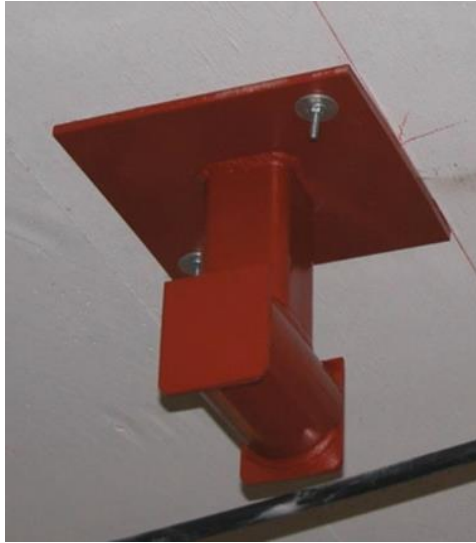
FIGURE 4.8: King post or A-saddle (ACI-318, CEU)

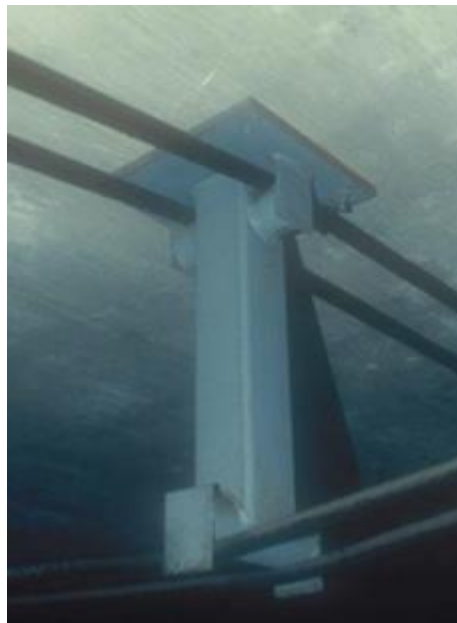
The 'B' saddle where in the downward reaction from the beam truss is applied at the top of the girder and the girder truss which carries the load to the column is at the bottom.

FIGURE 4.9: King post or B-saddle (ACI-318, CEU)

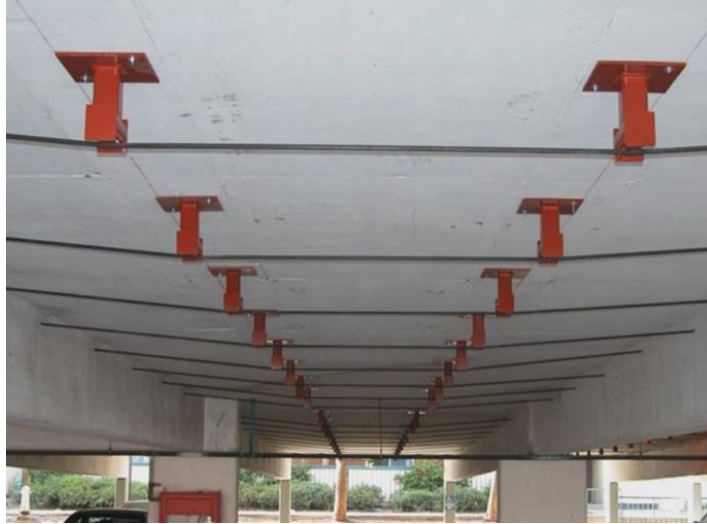
The following image is a typical example of a one-way slab strengthening.

FIGURE 4.10: One way slab strengthening (ACI-318, CEU)

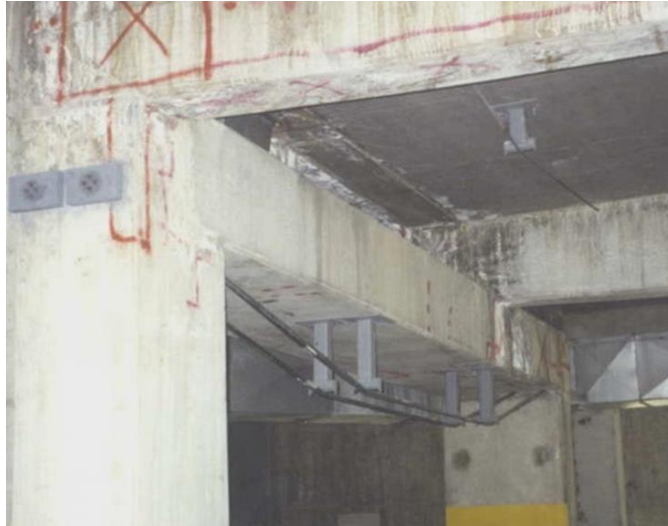
The girder shown in the image is to be strengthened. The headroom below the girder was good enough. The holes for the tendons are directly drilled at an angle. The king post is built under the girder instead of alongside.

FIGURE 4.12: Strengthening of girders and one-way slabs (ACI-318, CEU)

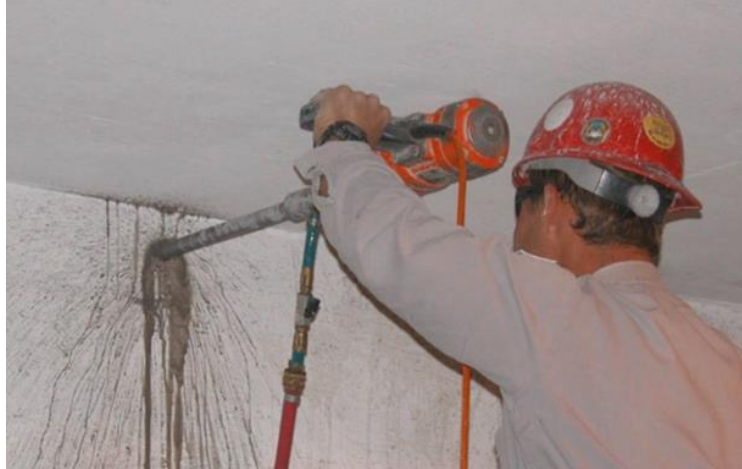
In those cases, with a single strand that have a 1.27cm diameter it is greased and wrapped if only one or two strands are needed to achieve the EPT system then the hole is done with a Roto-Hammer. For the cases where the system needs a 5-10 cm diameter holes then a regular core drilling equipment with diamond bits are used.

FIGURE 4.14: Coring using Roto-hammer technique (ACI-318, CEU)

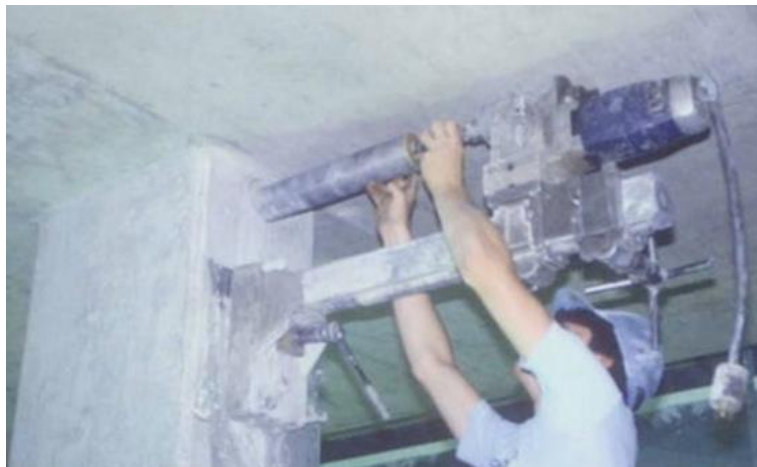
FIGURE 4.15: Coring using special equipment for larger holes (ACI-318, CEU)

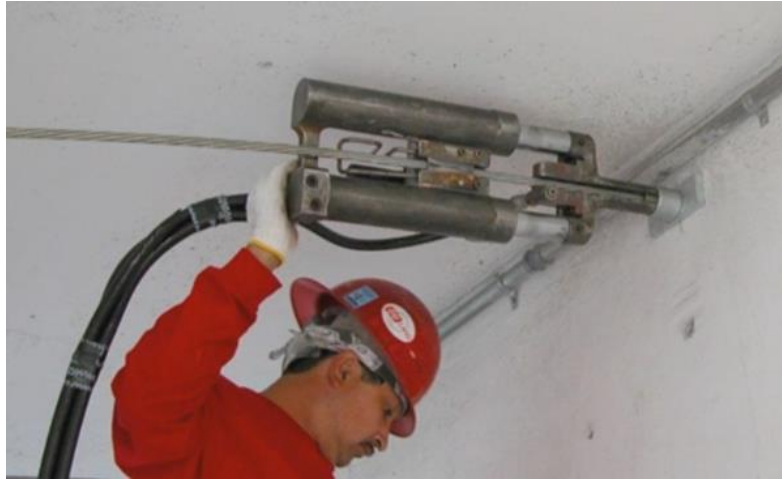
The tendons are stressed with a conventional stress equipment as shown in the image.

FIGURE 4.16: Stressing of tendons (ACI-318, CEU)

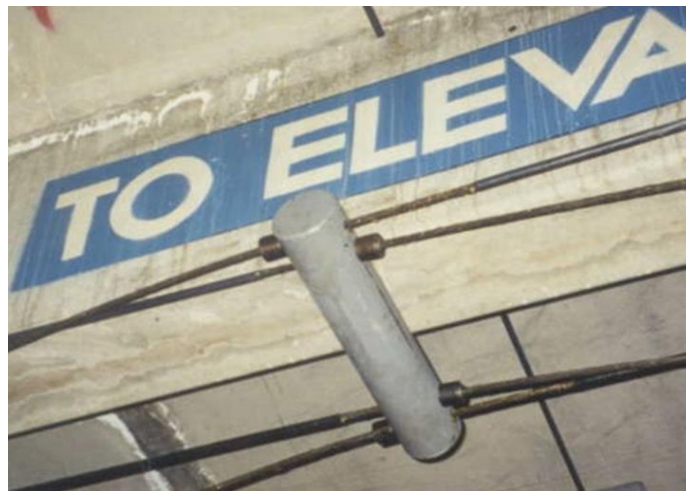
For those buildings where interior stressing is required then a double extra strong steel pipe is used then the strands are overlapped like in the image shown at the centre of the structure and stresses each strand in the required direction. This is one of the effective methods allowing to stress all tendons from the inside of a structure.

FIGURE 4.17: Method of centre stressing (ACI-318, CEU)

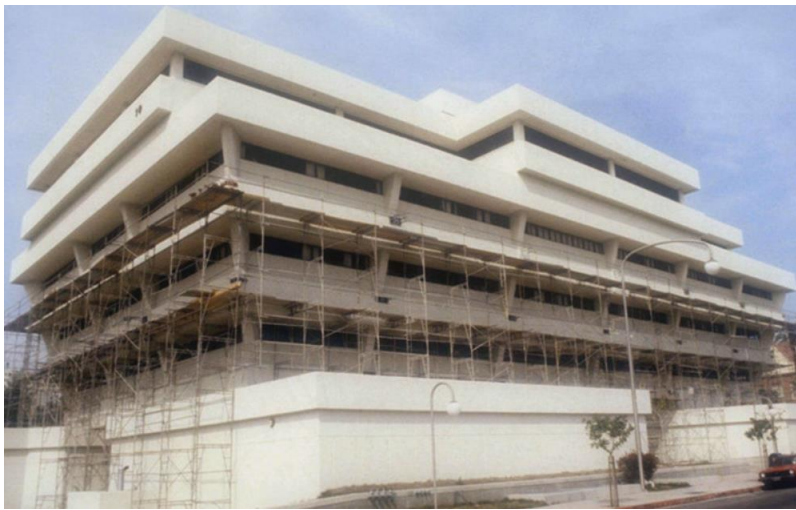
The orange county hall of administration is a building which is the centre of government severely affected by the earthquake. It is in the Southern California in the United States. The building contained an offices and meeting rooms as well as other default rooms. In this building the columns are inclined outwards which would allow to increase the area of the floors as the height increases. The building was built in the 1980 after which it experienced a moderate seismic event at 5.0.

FIGURE 4.18: Orange county hall of administration (ACI-318, CEU)

The use of external tendons did not involve applying the loads in the upward direction but it was applied in the horizontal direction. The building was severely affected by the earthquake. After the investigation it was found to have an engineering mistake which is the horizontal tension load that is required or exerted into the floor system which would prevent the columns from outward rotation was not taken into consideration. However only the eccentricity of vertical load in the columns where only calculated.

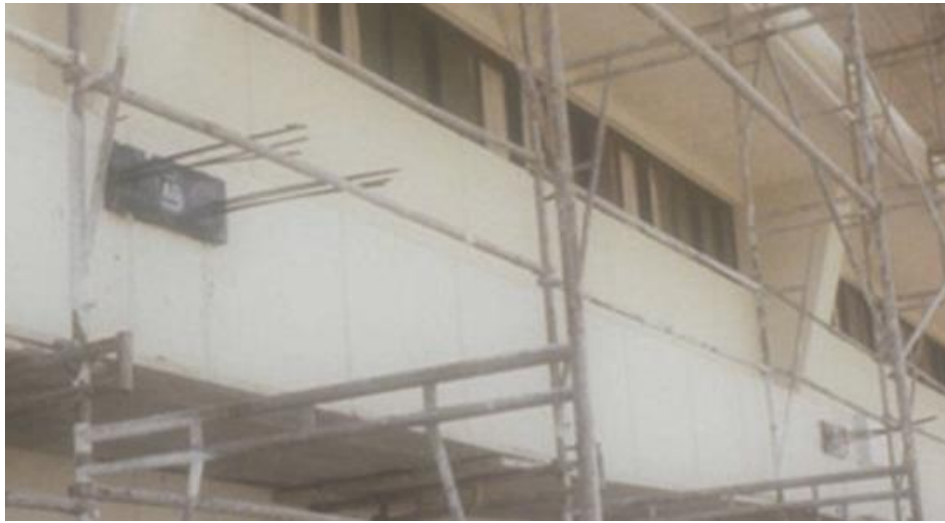
FIGURE 4.19: Anchor bearing plates for tendons (ACI-318, CEU)
