# **Seismic Retrofitting of Reinforced Concrete Structures**

**Dissertation submitted in fulfilment  
of the requirements for the degree of  
MSc STRUCTURAL ENGINEERING  
at**

**The British University in Dubai**

**October 2018**

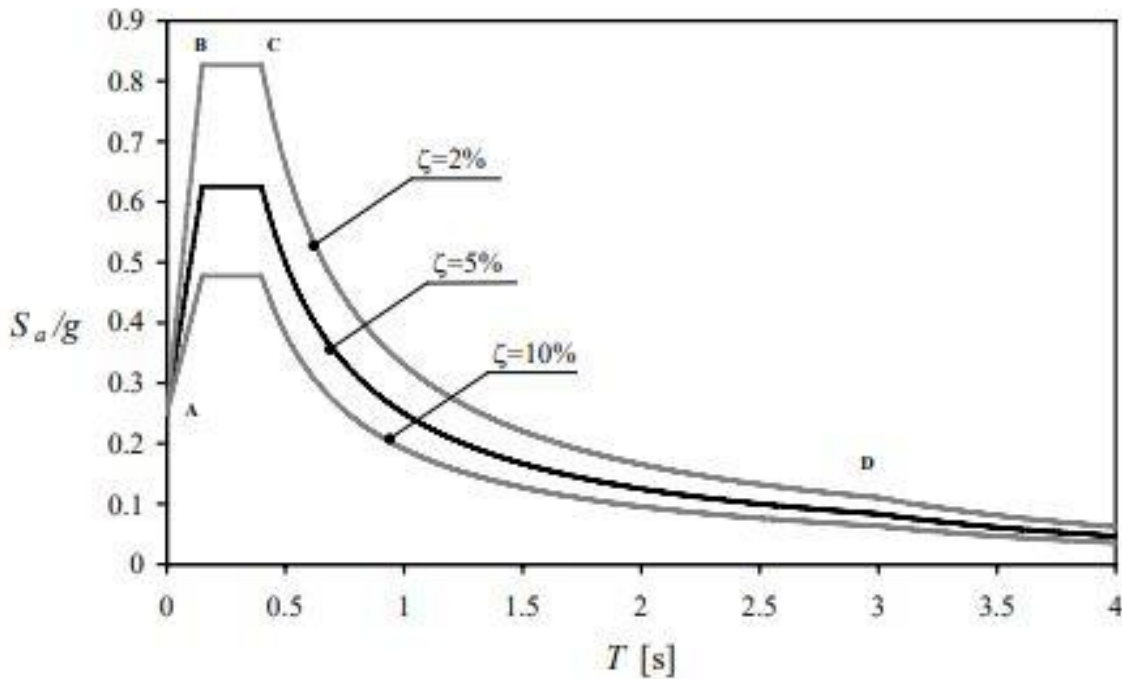
In the first region ( $0 \leq T \leq T_B$ ) where  $T_B$  is the lower limit of the period, the spectral ordinates escalates linearly with the time period and on the second region where ( $T_B \leq T \leq T_C$ );  $T_C$  is the upper limit of the period. At this region, the spectral ordinates are independent of the time period and when the period is greater than  $T_C$ ; spectral ordinates decreases rapidly leading to the reciprocal of the time period. When the time period decreases to  $T_D$ , spectral ordinates will decrease further leading to the reciprocal of the time period squared.

Figure-01: Elastic design spectrum of Eurocode 8, soil type A

means of a Design Spectrum which depends on the energy dissipation capacity through the Structure Behavior Factor. Assuming that the Structure Behavior Factor for the structure being considered can be evaluated, the Design Spectrum can be prepared. An example of such a spectrum is shown in Figure 01.

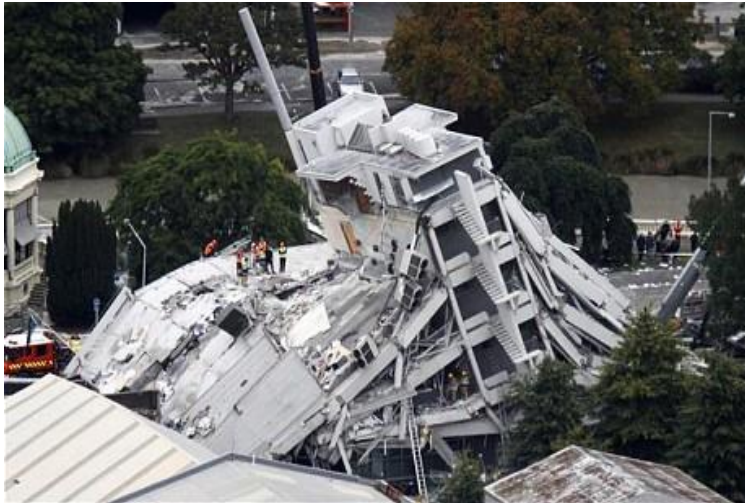
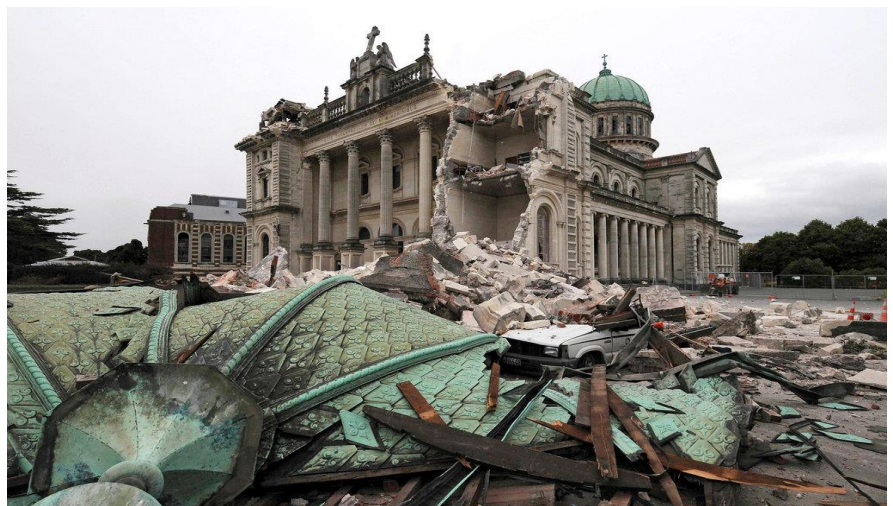
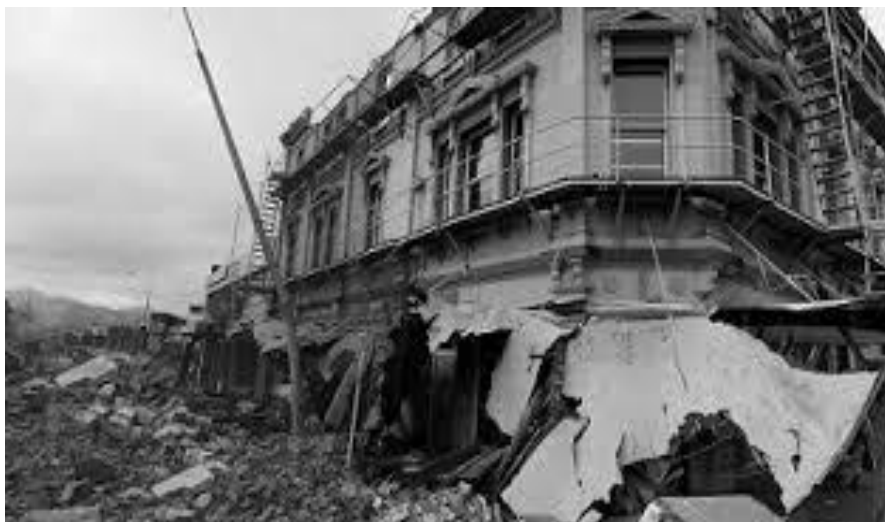
Historic structures were badly damaged and its stone chambers had completely collapsed. A substantial number of the churches were heavily and adversely affected which were demolished days after the earthquake (Turner, 2012).

Figure-03: Pictures from Christ Church Earthquake, 2011

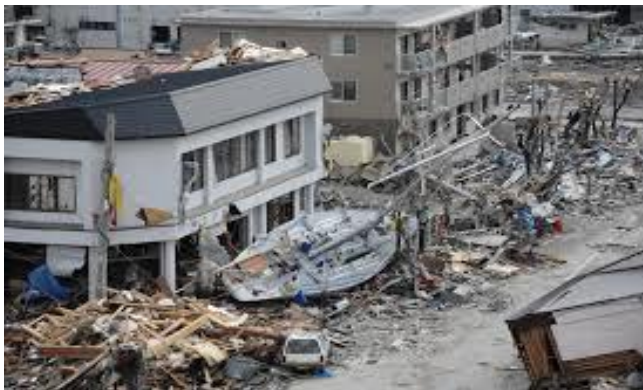
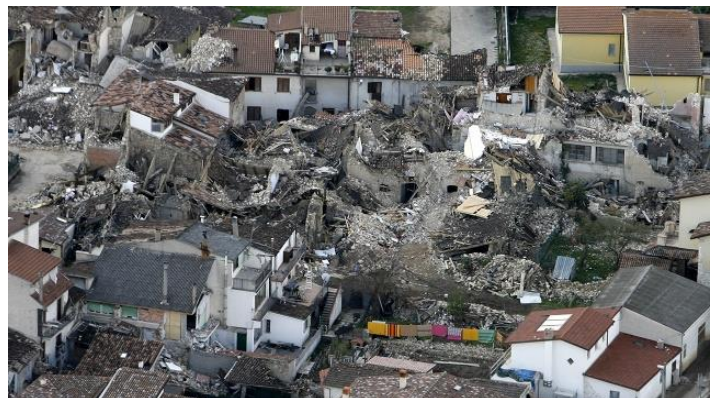
The damage to the infrastructure was very heavy, resulting in extensive and widespread structural damages to dams, railways, roads, buildings etc.

Figure-04: Pictures from Tōhoku Earthquake, 2011

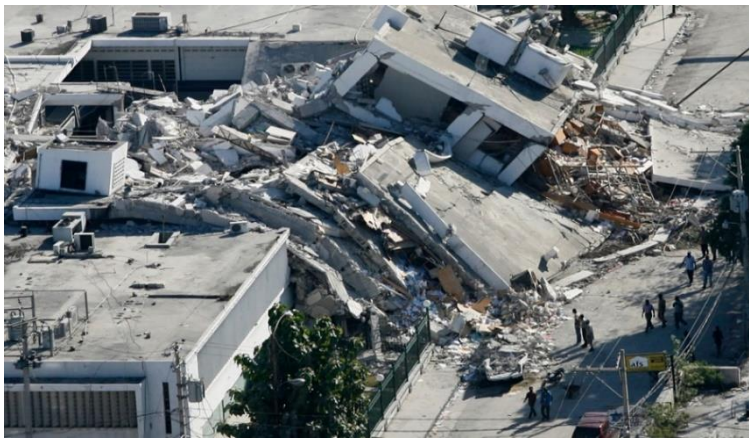
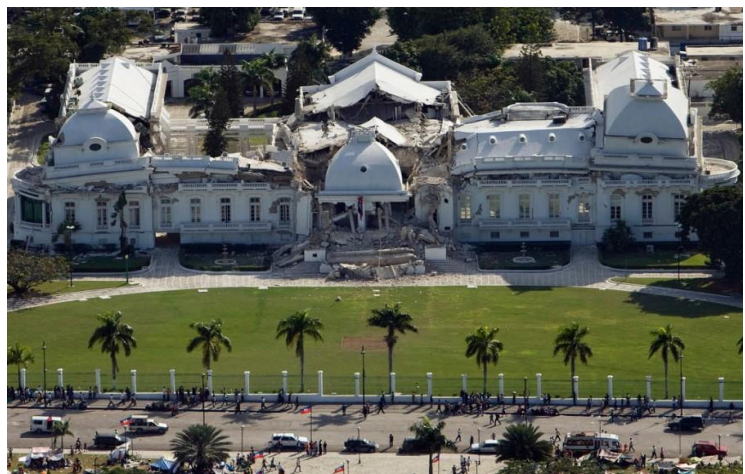
neighbours because of their low mass. For example, the wood-frame building withstood the earthquake forces while the adjacent structure collapsed after being reinforced concrete structure. Similarly, the one-story church had a light-metal roof supported by masonry walls. Although it appeared to be constructed with materials of poorer quality than those used in a neighbouring concrete bearing-wall house, the masonry church structure suffered less damage (Comerio, 2011).

Figure-05: Pictures from Haiti Earthquake, 2010

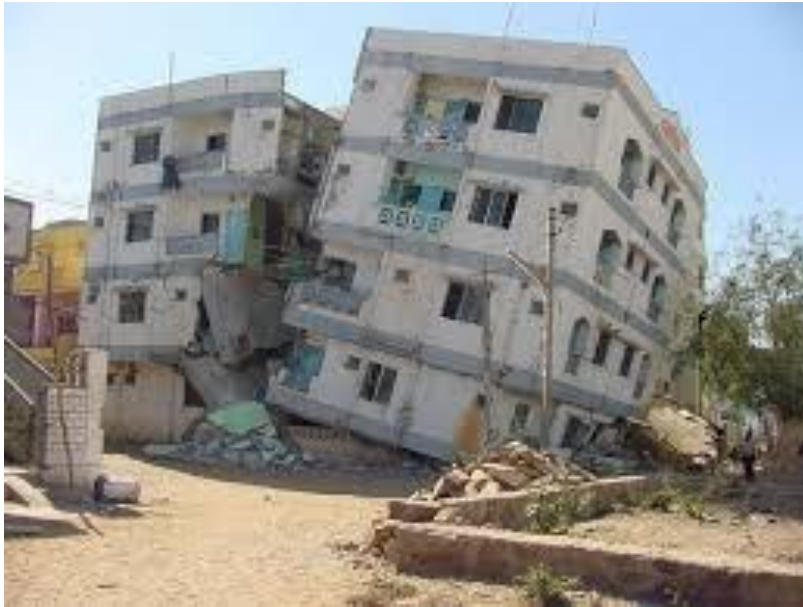
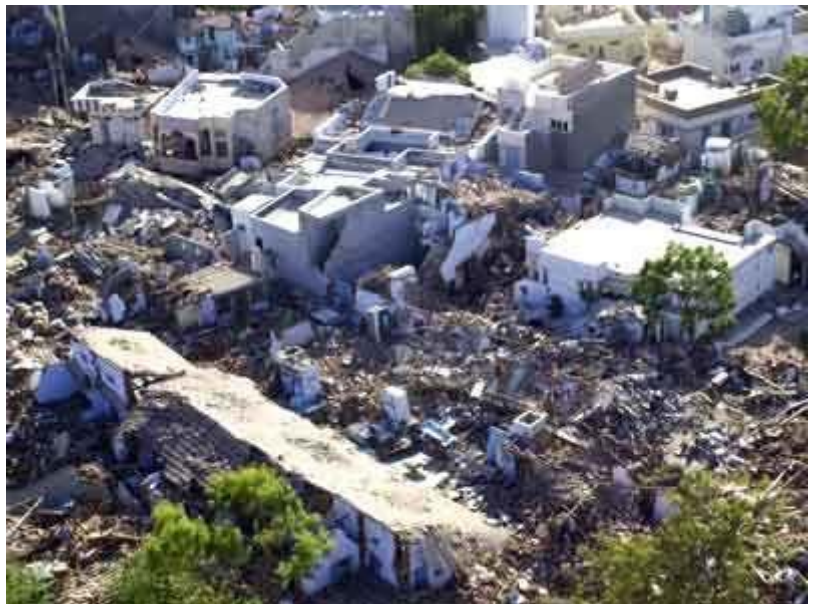
A review of the structures in the earthquake areas revealed that the majority of these structures consisted of reinforced concrete framed structure or load-bearing. The masonry units were made of random rubble stones, rough dressed stones, clay bricks, and concrete blocks either solid or hollow. Mortars of mud, lime or cement were used in assembling the units. The structure of the roof was made of Mangalore clay tiles which were laid on timber planks, supported by purlins or rafters made from wooden logs or made of reinforced concrete slab. In the building with more than one storey, the floors and roofs are more often to be non reinforced concrete slabs. The performance of the masonry structures, without any reinforcements, in the Kachchh areas performed very poorly during the earthquake. The walls were neither tied to each other nor to the floors and roofs. The random rubble constructions in mud mortar performed the worst here. Massive destruction and loss of life occurred from the collapsing of such large number of buildings. Many reinforced concrete frame buildings, except in the first storey, reserved as parking locations, had infill masonry walls. No wonder, the open first storey either collapsed or suffered serious damages. The review of such failures confirmed the vulnerability of those structural details which are known as causes of distress. In the majority of buildings, including those to 10 and 12 storied, the reinforced concrete columns are supported on isolated spread footings located at some depth below the ground level to go past the fill material on the top. Generally, it is found that the quality of foundation soil is judged on the basis of visual inspection, without any geotechnical investigation having been carried out. Foundation ties are not provided. However, surprisingly, it was found in the review process of the earthquake that masonry infills, even when

Figure-07: Pictures from Bhuj Earthquake, 2001

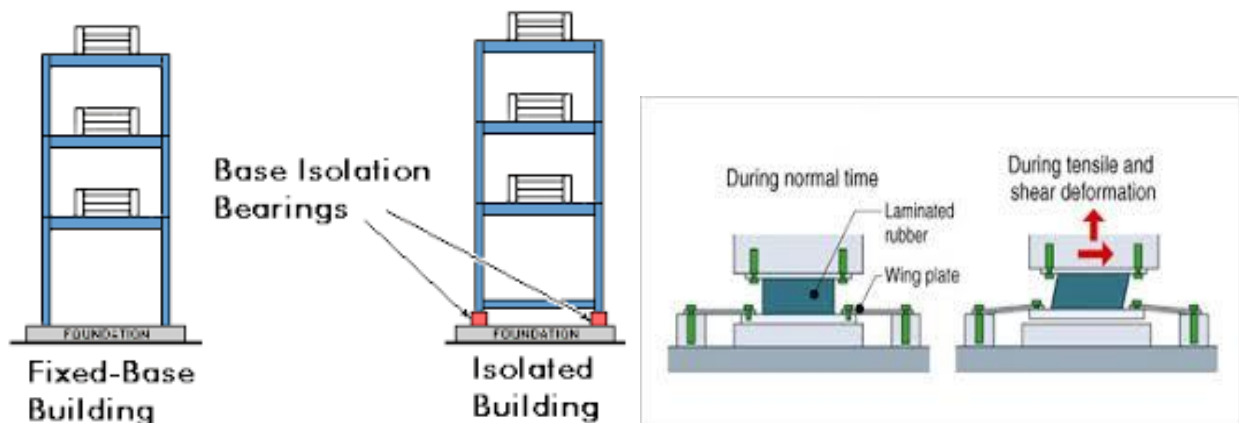
Inducting flexibility at the base of the structure horizontally, and infusing damping elements simultaneously in order for restricting the amplitude of the motion which an earthquake causes is, in principle, Seismic Isolation. The successful development of mechanical-energy dissipaters as well as elastomers possessing high damping properties boosted the concept of base isolation. The Use of Mechanical energy dissipation devices, combined with flexible base isolation devices, controls the seismic response of the structure by limiting displacements and forces. This significantly improves its seismic performance (Sinha, 2012).

Figure-08: Base Isolation devices

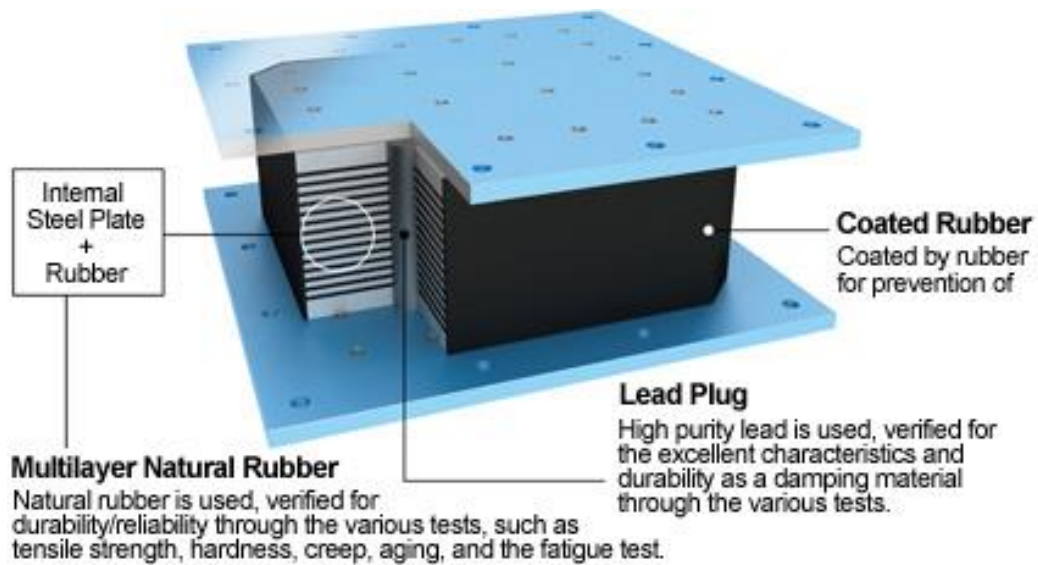
Figure-09: Base Isolation devices

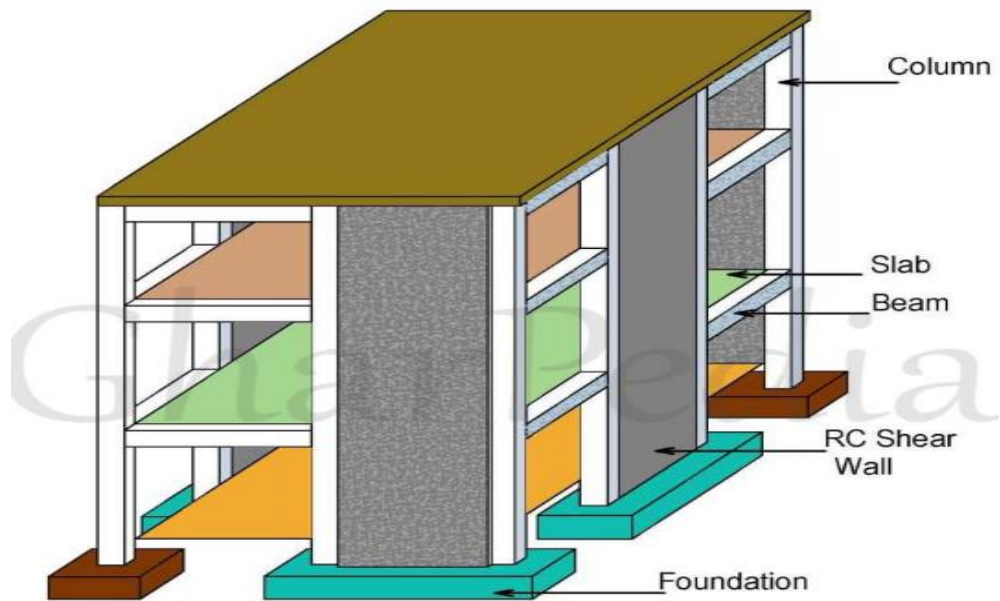
Location of shear walls also matters a lot. It is desirable to locate the new shear wall adjacent to the beam between columns so that only minimum slab demolition is required with connections made to beams at all sides of the columns.

Figure-10: Seismic Retrofitting with Addition of shear walls

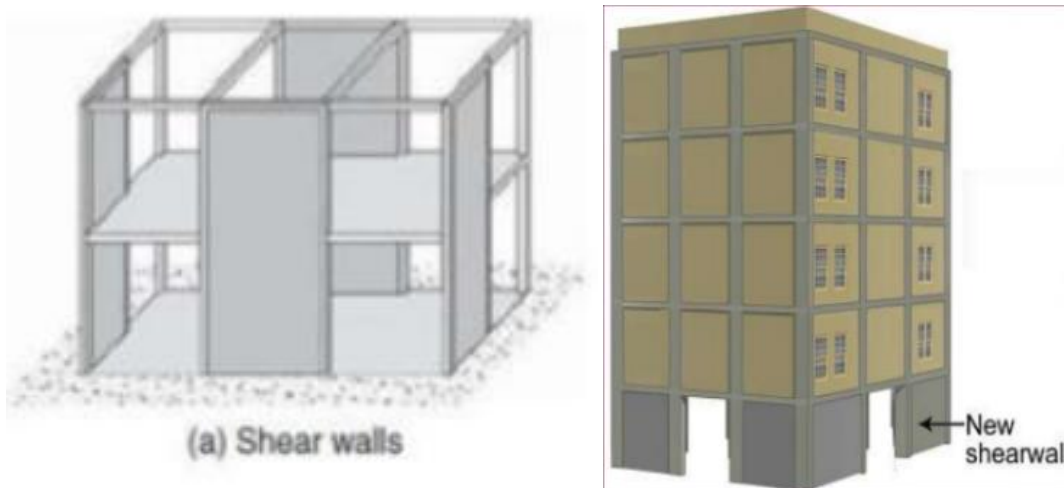
Figure-11: Seismic Retrofitting with Addition of shear walls

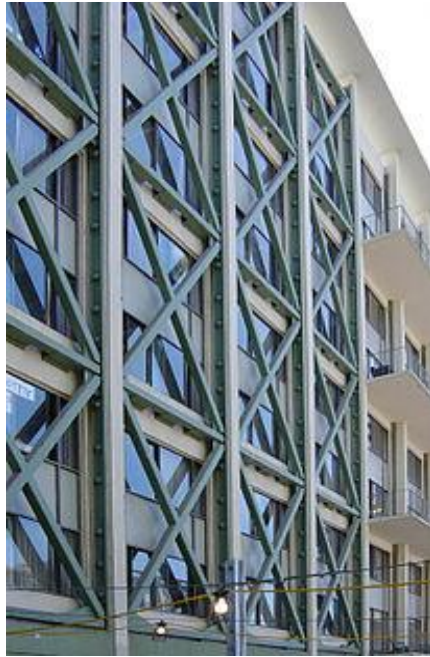
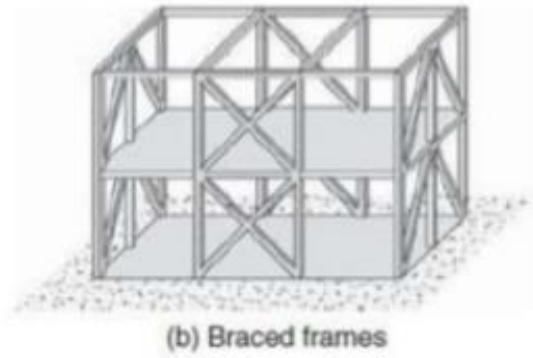
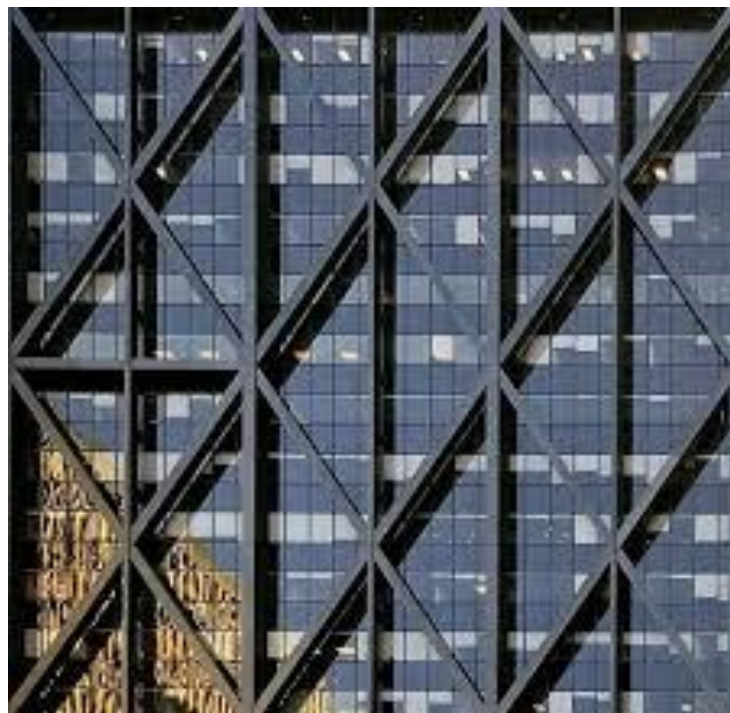
Bracing should have low slenderness ratio so as to function effectively during compression. Skilled labour is crucial for steel bracing construction. Careful considerations of connections of strengthening elements to the existing structures and to the foundations have to be consciously designed to ensure proper shear transfer. Local reinforcements to the columns may be needed to bear the increased loads generated on them.

Figure-12: Seismic Retrofitting with Addition of Steel bracings

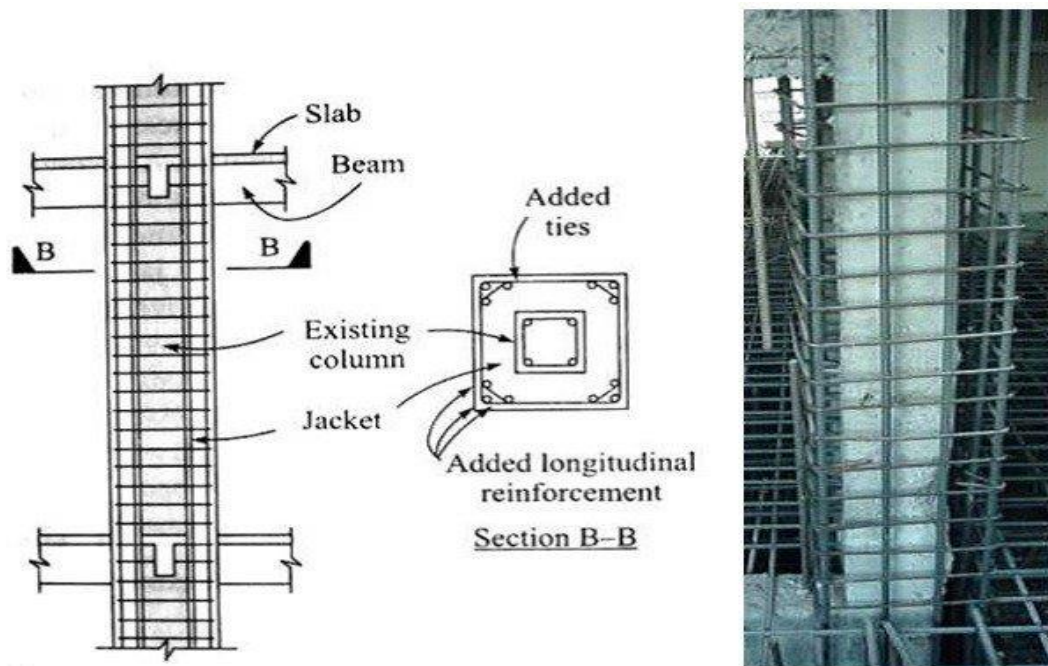
Jacketing increases the shear capacity of the columns in order to accomplish strong column-weak beam design, and to improve the column's flexural strength by the longitudinal steel of the jackets.

Figure-13: Seismic Retrofitting with Jacketing of Columns

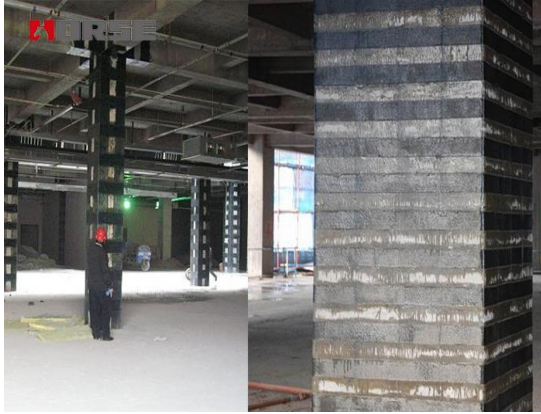
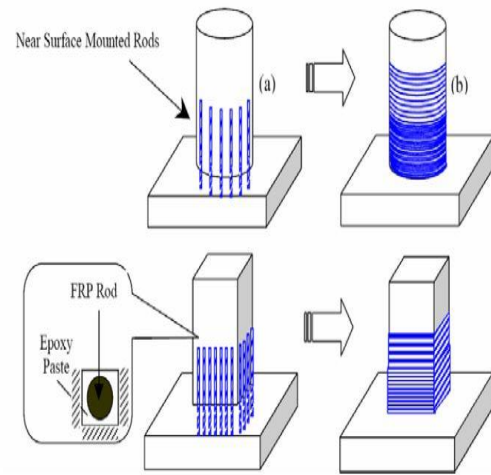
- i. Carbon fibre is flexible and can be made to contact the surface tightly for a high degree of confinement.
- ii. Confinement is very strong and effective because carbon fibre is highly strong and of high modulus of elasticity
- iii. The carbon fibre has light weight and rusting does not take place.

Figure-14: Seismic Retrofitting with Jacketing of Columns using FRP wrapping

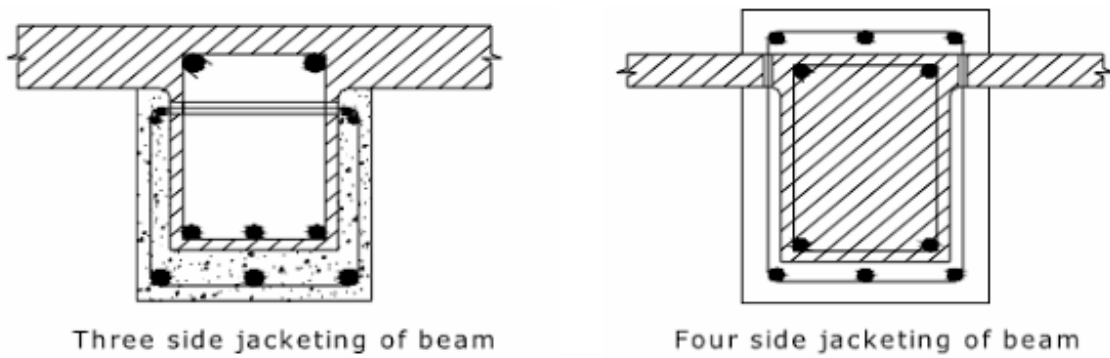
Figure-15: Seismic Retrofitting with Jacketing of Beams

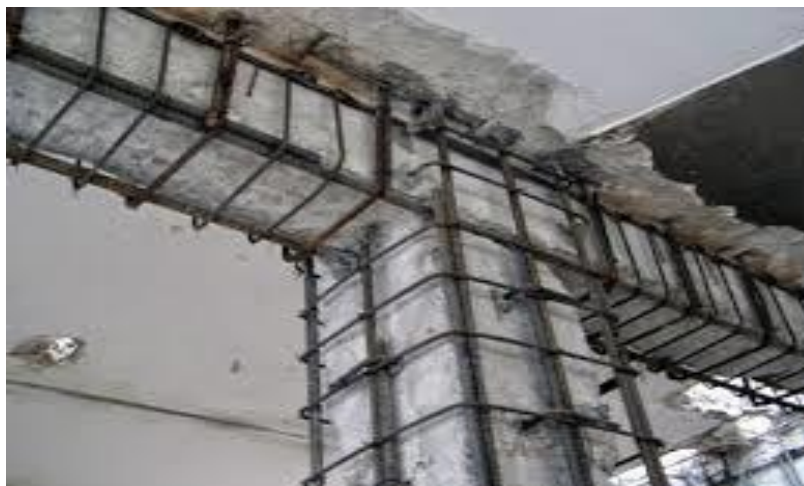
- Jacketing by concrete can increase both flexural and shear capacities of a beam.
- The compatibility of deformation between the existing and new concrete, resistance against delamination, and durability are better as compared to a new material on a different substrate.
- The analysis of retrofitted sections follows the principles of analysis of RC sections.

Figure-16: Seismic Retrofitting with Jacketing of Beams

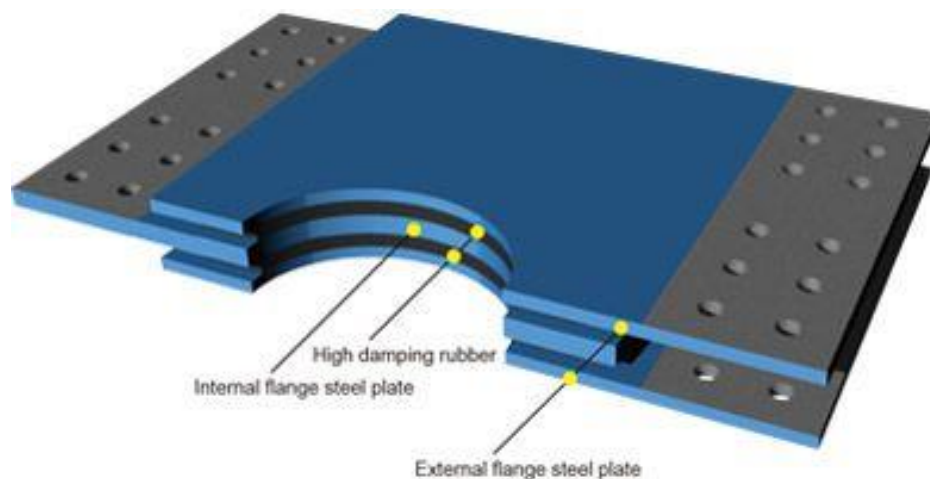
Figure-17: Supplementary Damping Devices

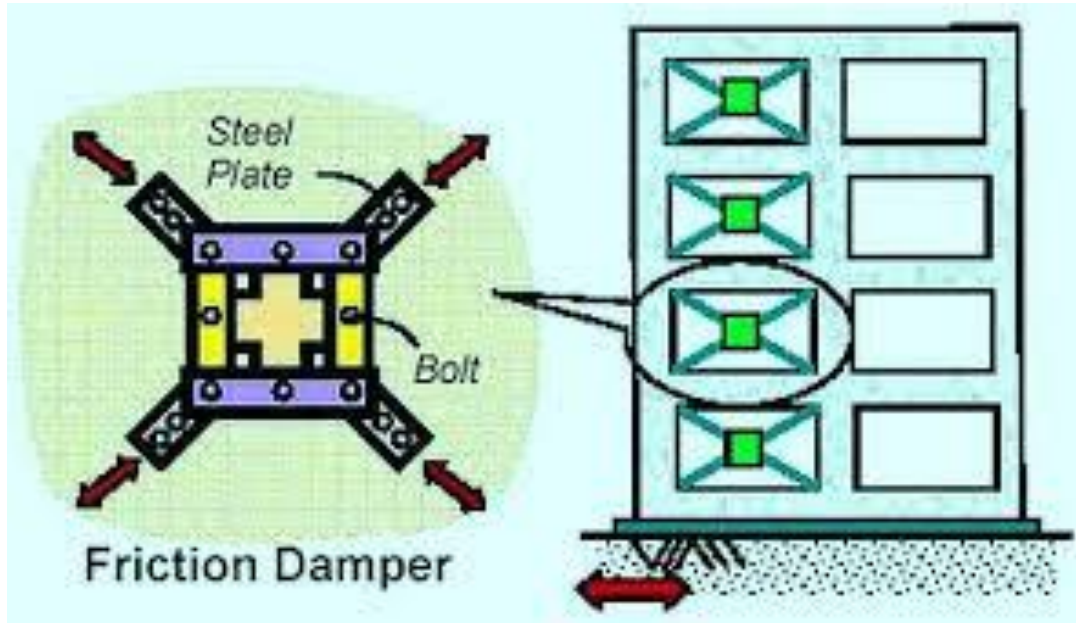
A substantially larger increase in damping may lead to a sizeable reduction in accelerations, provided, the structure is retrofitted to respond only elastically.

Figure-18: Supplementary Damping Devices

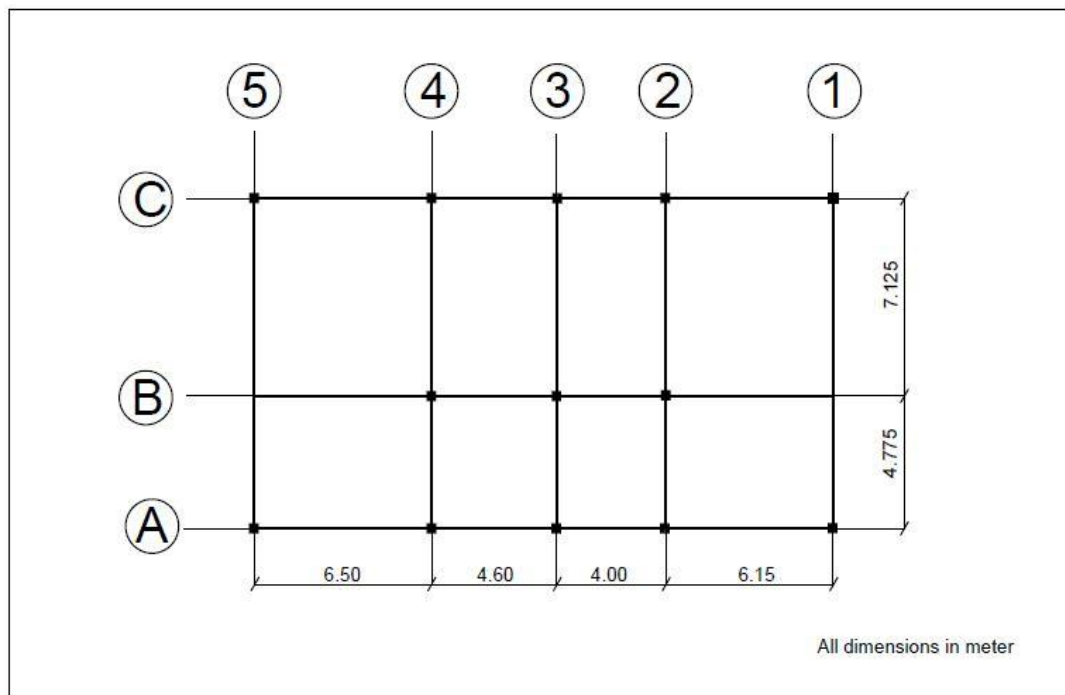
Figure-19: Typical floor plan with column layout

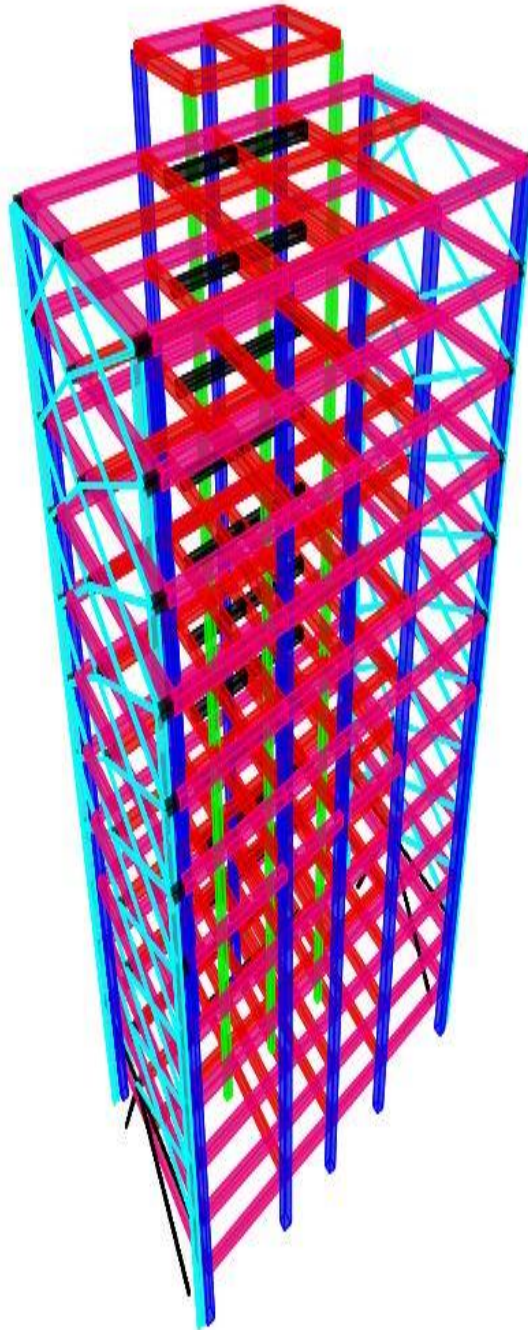
**Scheme-01: Structure retrofitted using Steel Bracing.**

Figure-20: 3D model from the software

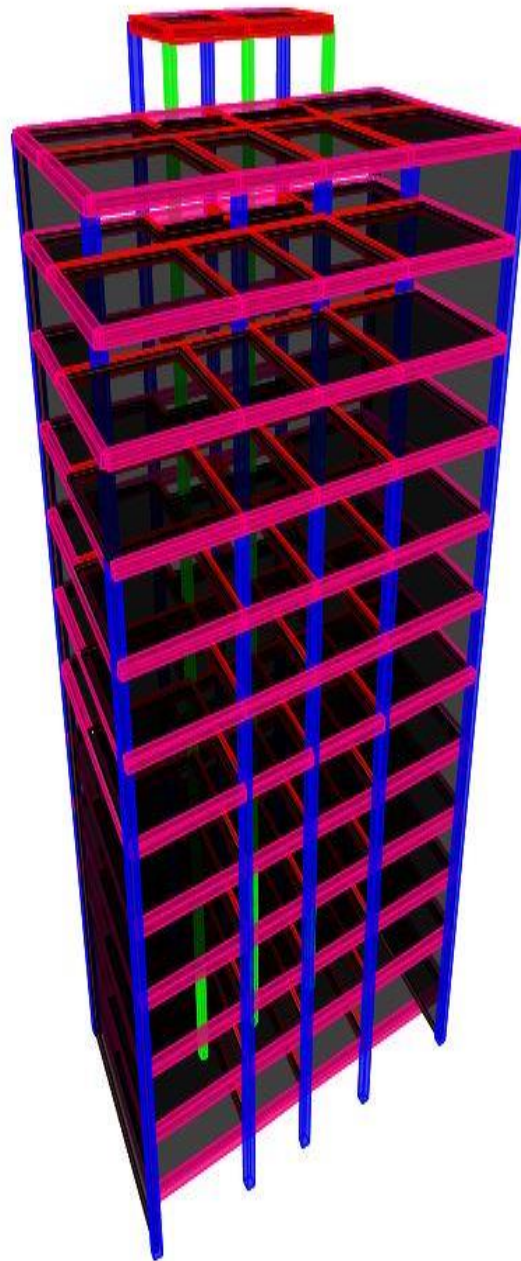
**Scheme-02: Retrofitted Structure Using Ductile Reinforced Concrete Shear Walls.**

Figure-21: 3D model from the software

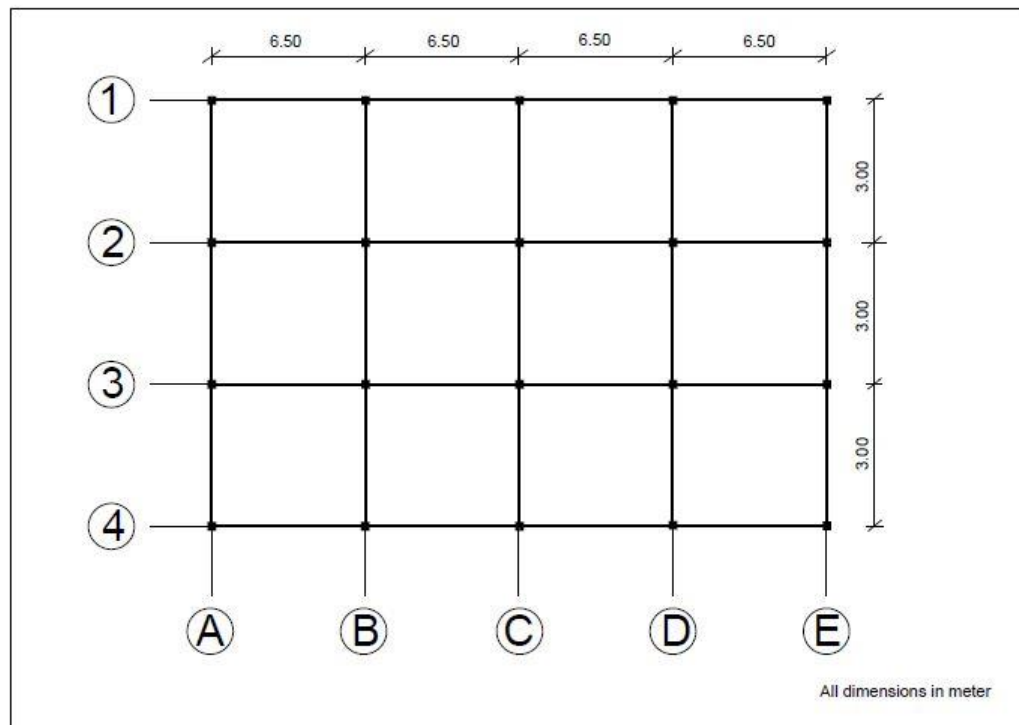
Figure-22: Typical floor plan with column layout

In the study of structure-02, almost the same procedures were adopted. The structure-02 was initially retrofitted and strengthened by the addition of ductile reinforced concrete shear walls on the exterior frames along grids 1, 4 between A-B and D-E and along grids A and E between 1-2 and 3-4. The floor plan of the structure-02 is shown on figure-21.

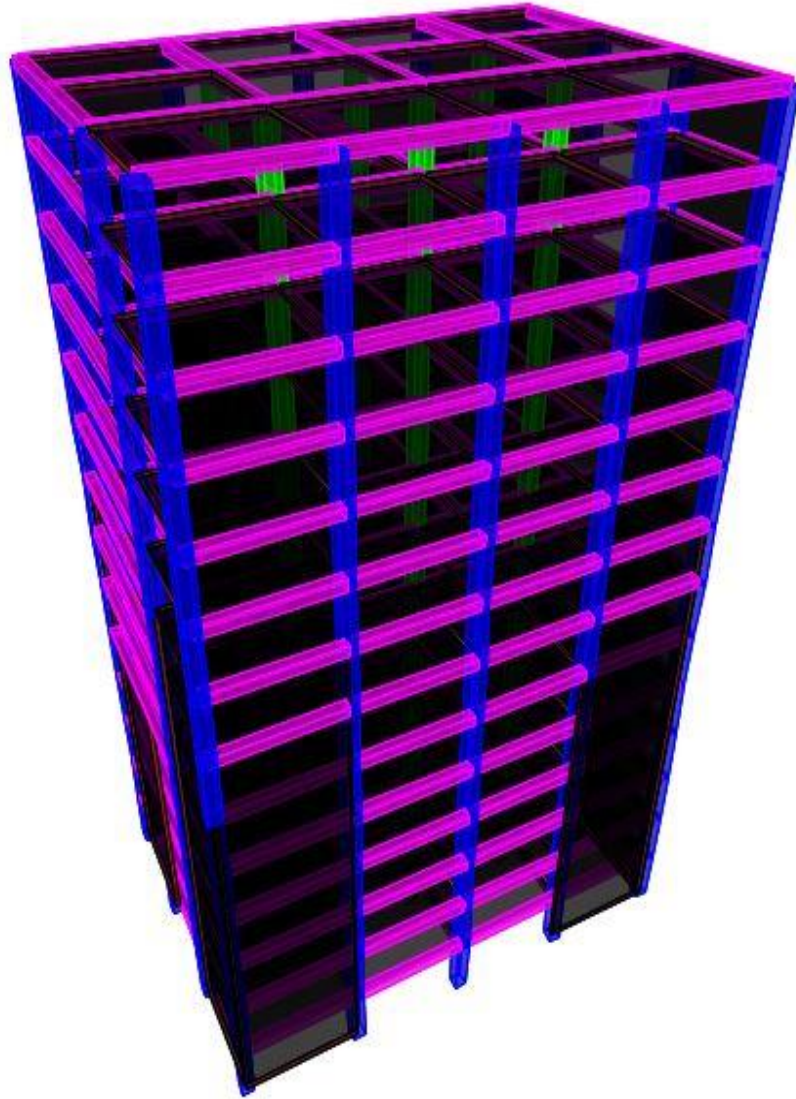
**Scheme-03: Retrofitted Structure using Ductile Reinforced Shear Walls.**

Figure-23: 3D model from the software

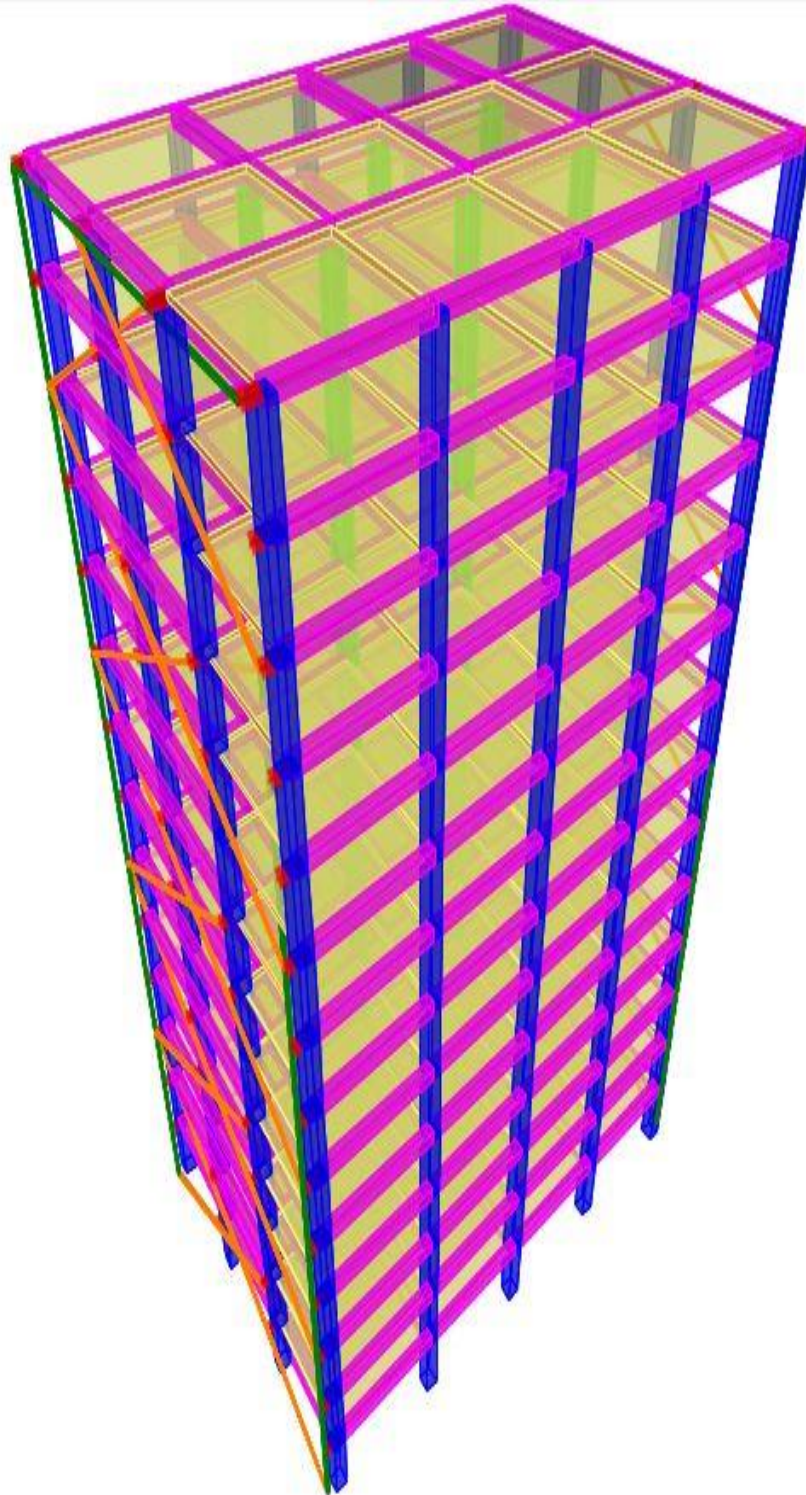
In the present study, the efforts are made to retrofit the same building by the addition of steel bracing in one direction on two frames on grids A and E and new infill reinforced walls on the grids 1 and 4.

**Scheme-04: Retrofitted Structure using Steel Bracing.**

Figure-24: 3D model from the software

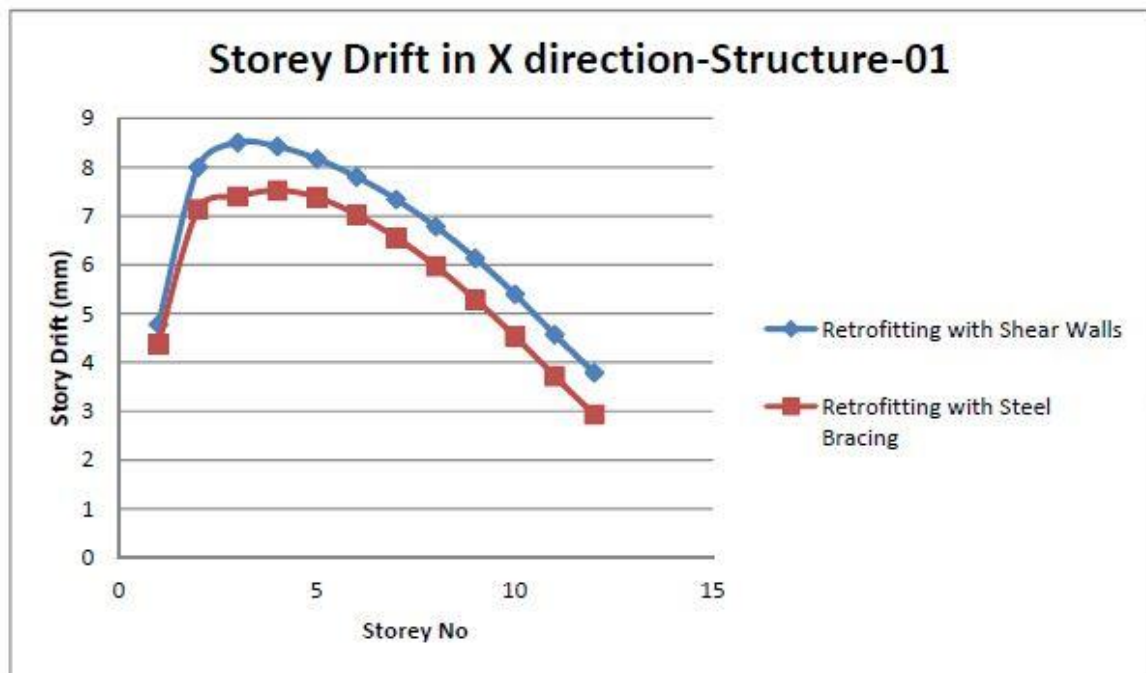
Figure-27: Story Drift of structure-01 in X-direction

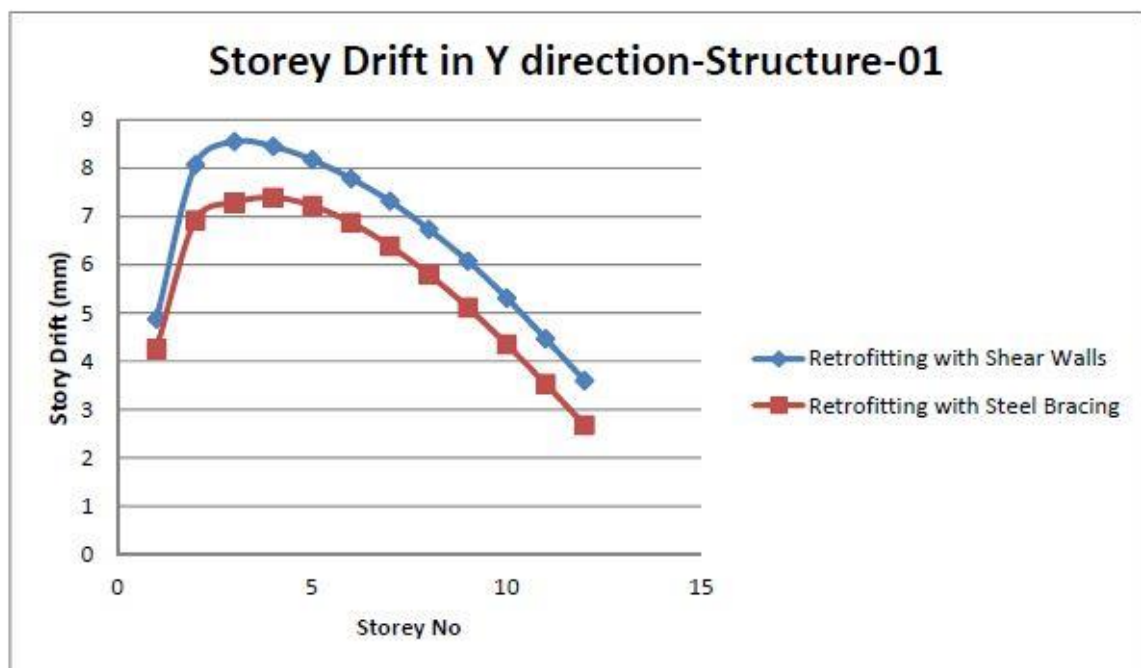
Figure-28: Story Drift of structure-01 in Y-direction

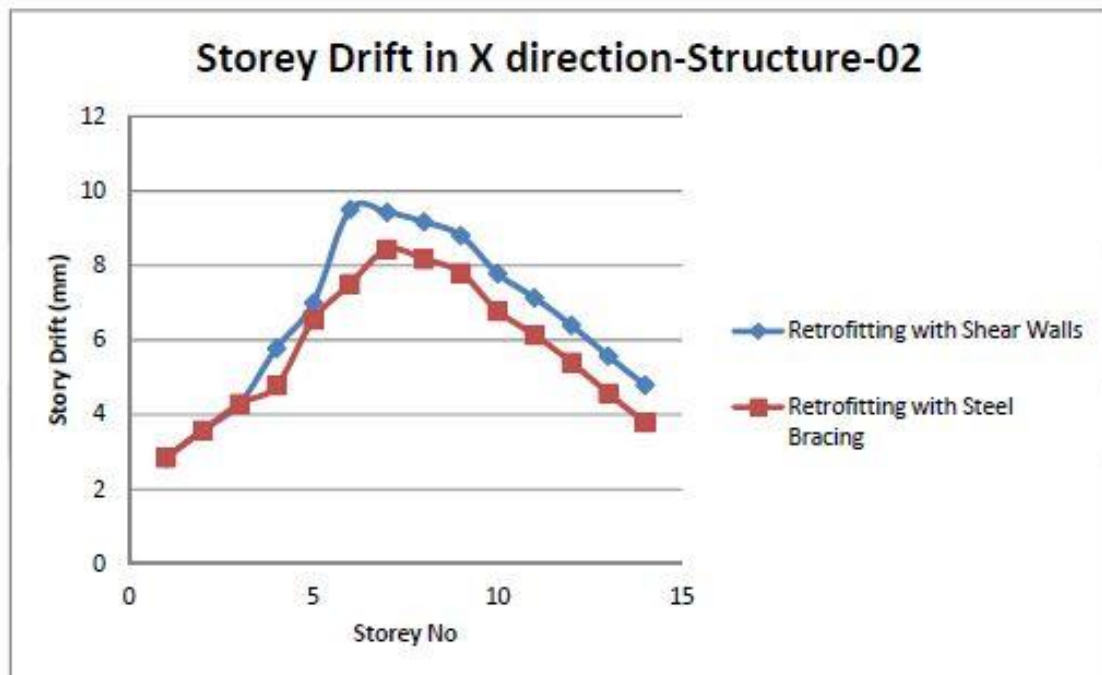
Figure-31: Story Drift of structure-02 in X-direction

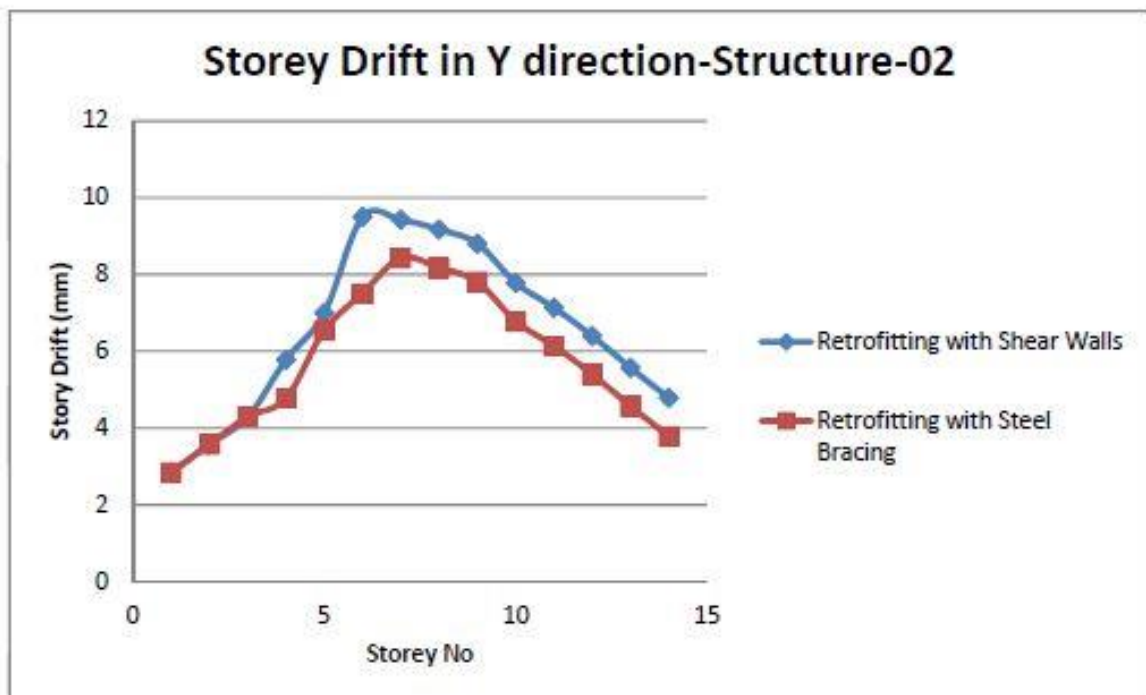
Figure-32: Story Drift of structure-02 in Y-direction
